# **Underground Storage Tank Report**

*Pine Brook Housing – Bldg. 3216*

**NJDEP UST Registration No. 192486-11**

**UNDERGROUND STORAGE TANK CLOSURE  
AND REMEDIAL INVESTIGATION REPORT**

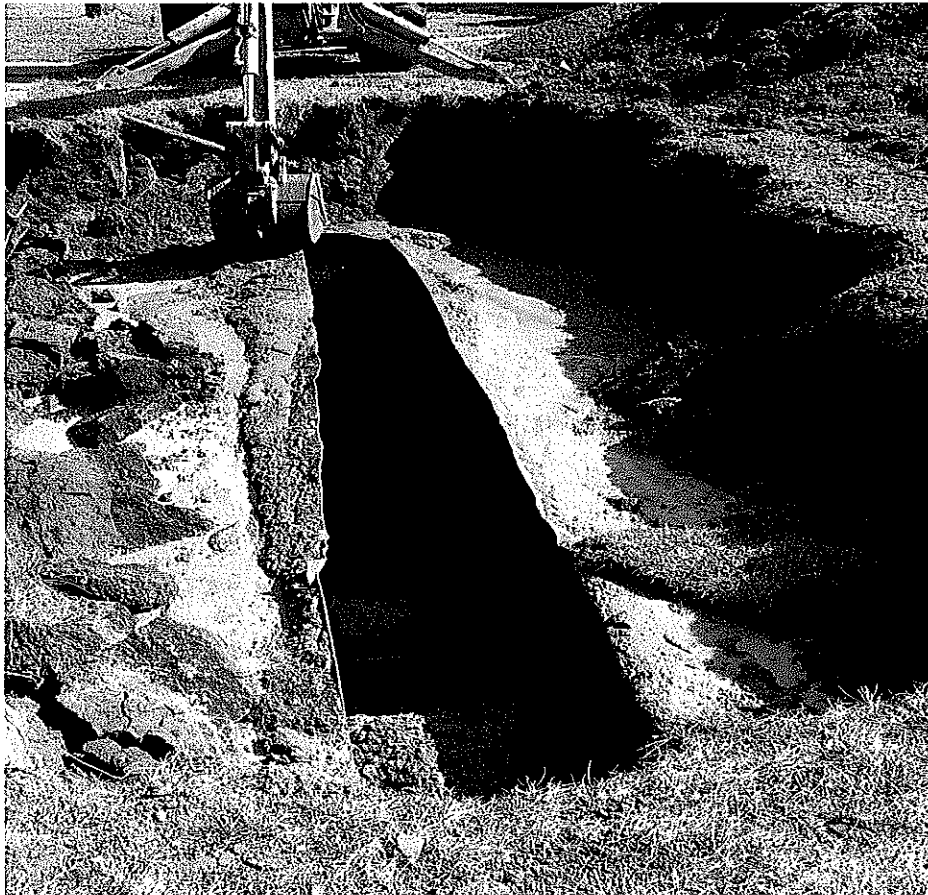
**Tank emptied of the sand contents**

The top of the tank was removed to allow for access during the abandonment process. The tank was filled with sand and left in place. The sand was removed from the tank and taken to the ID 27 storage area for subsequent disposal. The UST was then cleaned with rubber squeegees and the remaining material broomed from the sidewalls and bottom. The materials were then drummed and subsequently put into Ft. Monmouth's 'Oil Spill Debris' roll-off container for proper disposal. The atmosphere in and around the tank was monitored using an OVM and an Oxygen/Lower Explosive Level (LEL) meter to ensure safe working conditions during cutting and cleaning activities.

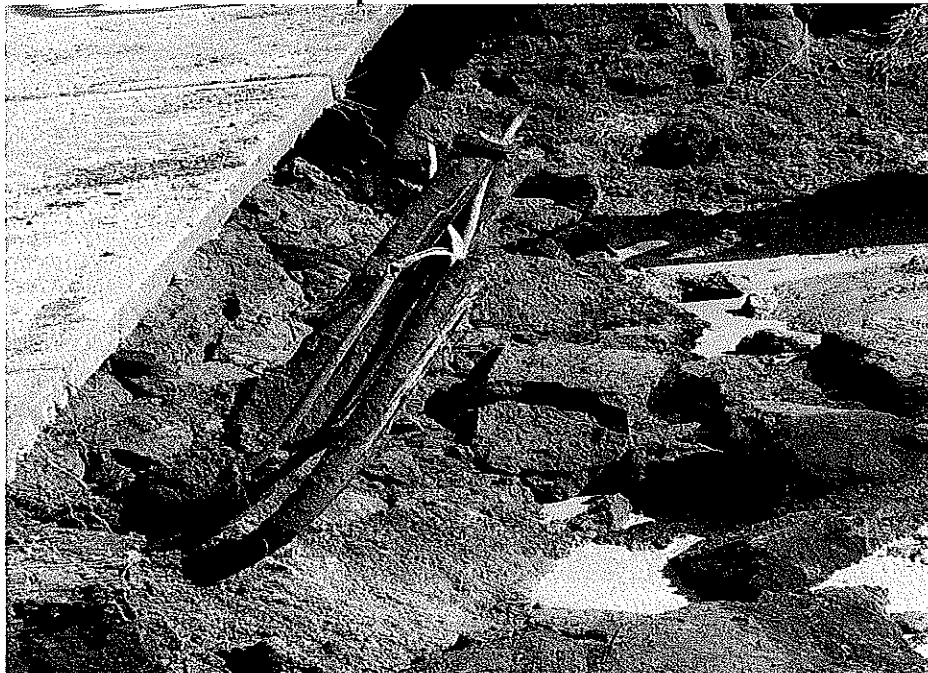
**CUT UTILITY LINES IN THE EXCAVATION**

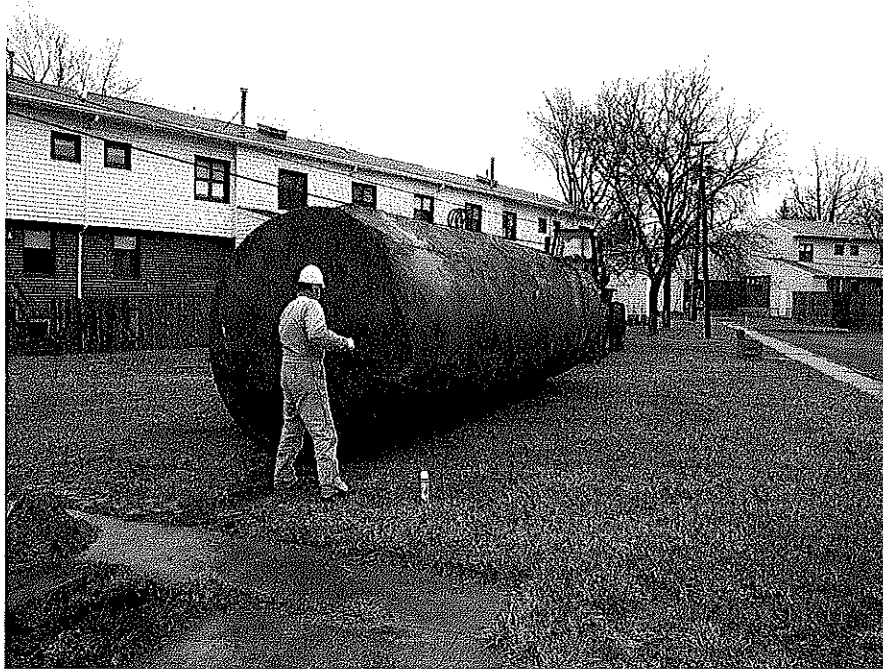
**TANK REMOVED FROM GROUND**

After the UST was removed from the excavation, it was staged on the ground, labeled and examined for holes. No holes in the tank were observed during the inspection by the Subsurface Evaluator. Soils surrounding the UST were screened visually and with an Organic Vapor Monitor (OVM) for evidence of petroleum contamination. No soil staining and an odor of fuel were observed. After removal, the tank was transported for storage at the Bldg. 108 pad for subsequent cutting and disposal.

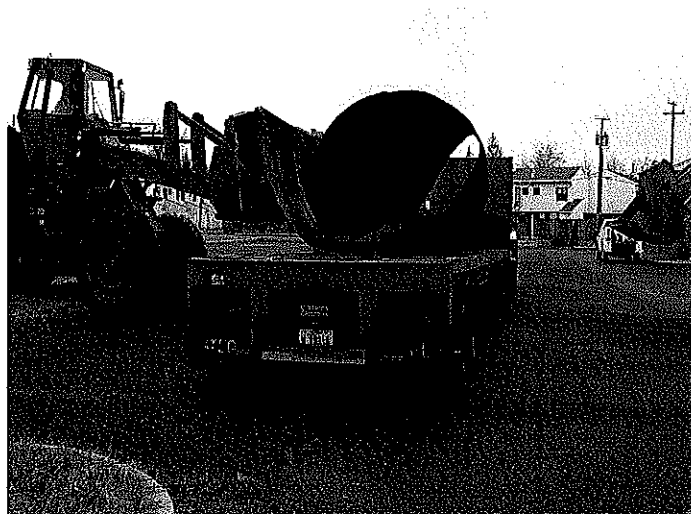
**TANK BEING LOADED FOR OFF SITE TRANSPORT**

The steel tank was cut into manageable pieces and placed into a 7 cubic yard dump truck and shipped off site to be recycled. Refer to Appendix C for UST disposal certificate. The tank contents were sampled and used as clean back fill materials in the excavation. See Table 2 for results.
