**U.S. Army Garrison Fort Monmouth  
Restoration Advisory Board (RAB)  
October 7, 2009 ~ 7:00 p.m.**

# 2005 BRAC Fort Monmouth Baseline Ecological Evaluations Site Visits

### Underground Heating Oil Tank (UHOT) removal update

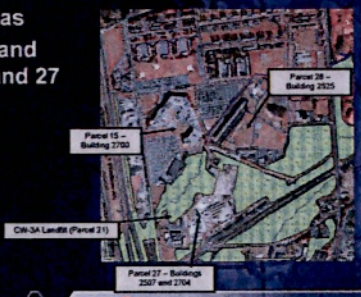
**Parcels 15, 27, 28 & Landfill CW-3A**

- Forested Areas
- Near CW-3A and between 15 and 27

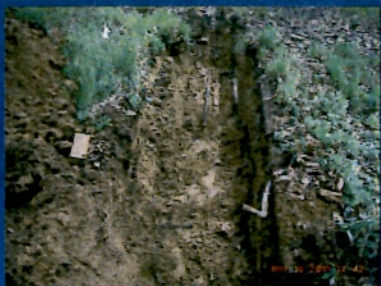
### Parcel 14

No Underground Heating Oil Tanks (UHOTS) were found. Pipes and debris were present. No sample was collected, the excavation was backfilled with clean fill.

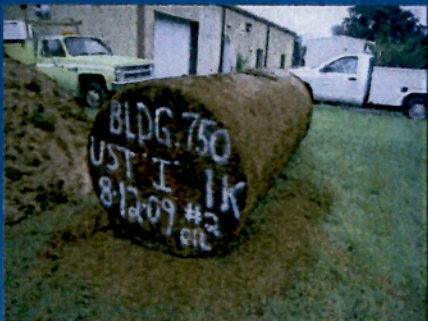
### Site P51-5

No pitting or holes were found in the tank

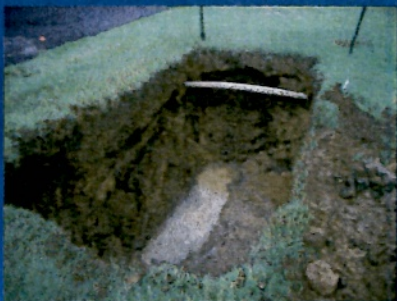
### Site P51-5

No contaminated soil was found, post excavation samples were collected and came back below regulatory levels.

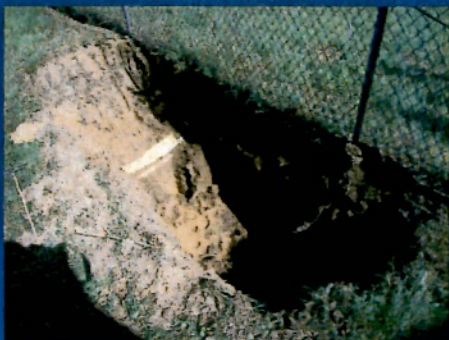
### Site P51-15

No UHOT was found. A natural gas main and metallic dig tape were found in the excavation.

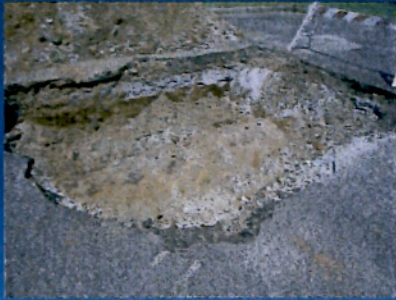
### Site P51-27

1000-gallon UHOT. 275 gallons of oil and water were pumped from the tank.

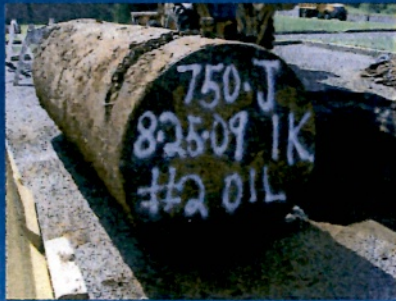
### Site P51-27

Some small holes and pitting were observed during the tank inspection.

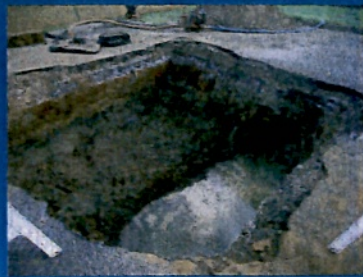
### Site P51-27

24 cubic yards of petroleum contaminated soil was excavated from the site and transported to the soil pad behind Building 166. Post excavation samples were collected and came back below regulatory levels. The site was backfilled with clean fill.

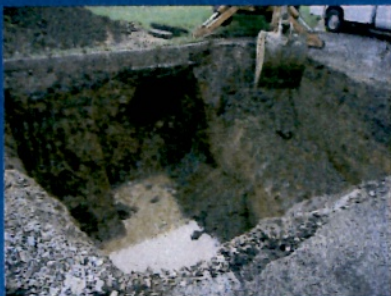
### Site P 51-31

60 cubic yards of petroleum contaminated soil were excavated from the site. The excavation was sampled and the results came back below regulatory levels. The excavation was backfilled with clean fill.

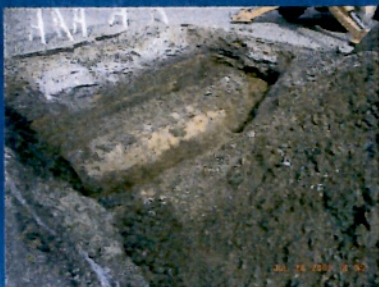
### Site P 51-38

1000-gallon UHOT. 320 gallons of oil and water was pumped out of the tank.

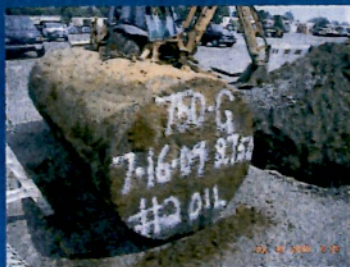
### Site P 51-38

Some small rust holes were observed during the tank inspection.

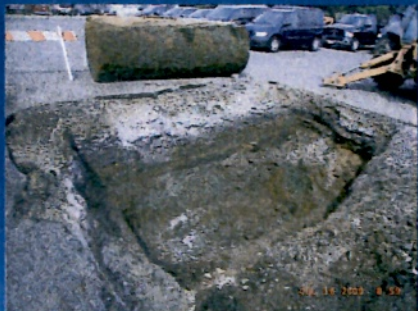
### Site P 51-38

42 cubic yards of petroleum contaminated soil was removed from the excavation. The excavation was sampled and backfilled with clean fill.

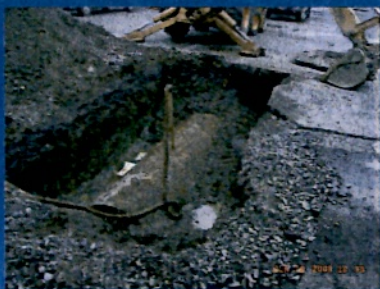
### Site P 51-42

1000-gallon UHOT. Pumped out 300 gallons of oil and water from the tank.

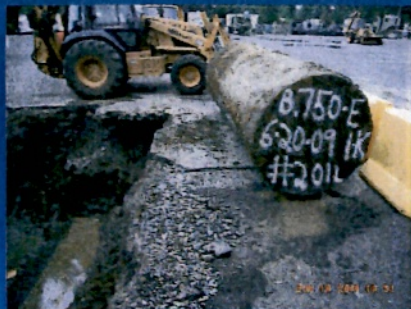
### Site P 51-42

The UHOT removed from excavation, inspected and labeled.

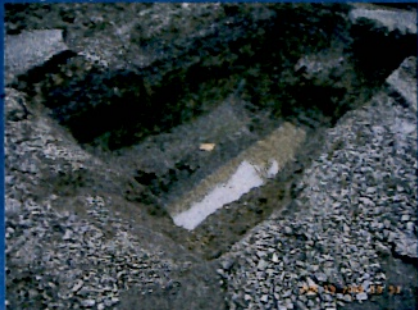
### Site P 51-42

24 cubic yards of petroleum contaminated soil was removed from the excavation. The excavation was sampled and the results came back below regulatory limits. The excavation was backfilled with clean fill.

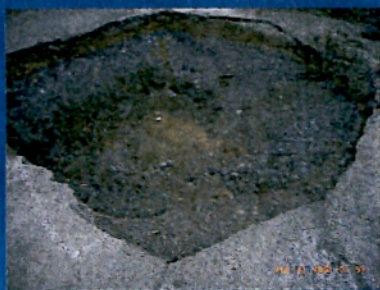
### Site P51-47

1000-gallon UHOT. Pumped 250 gallons of oil and water out of the tank.

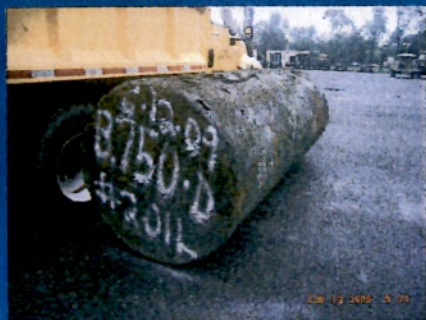
### Site P 51-47

UHOT removed from excavation, inspected, and labeled. Large rust holes are present.

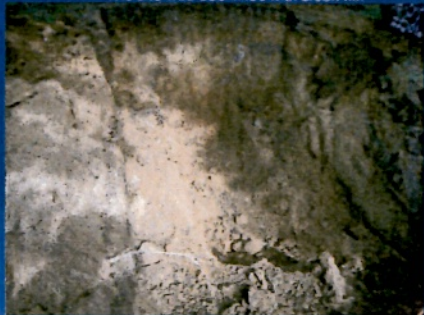
### Site P 51-110

12 cubic yards of petroleum contaminated soil was excavated from the site. The post excavation samples came back below regulatory limits. The site was backfilled with clean fill.

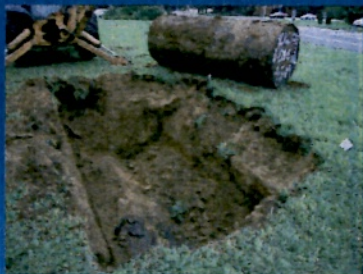
### Site P 51-111

1000-gallon UHOT. 120 gallons of oil and water was pumped out of the tank by Lorco.

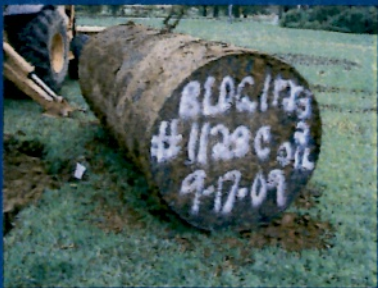
### Site P51-111

The UHOT was removed from the excavation, inspected and labeled.

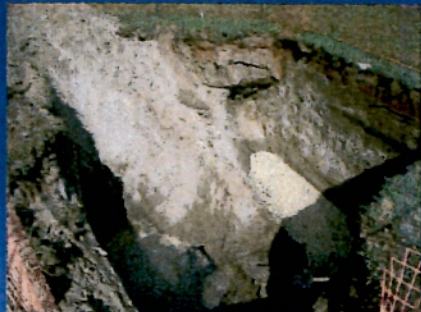
### Site P51-111

25 cubic yards of petroleum contaminated soil was excavated from the site. Post excavation sample results came back below regulatory levels. The site was back filled with clean fill.

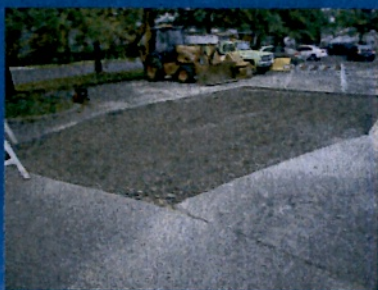
Currently paving Parcel 51 sites located in parking lots. Hole preparation.

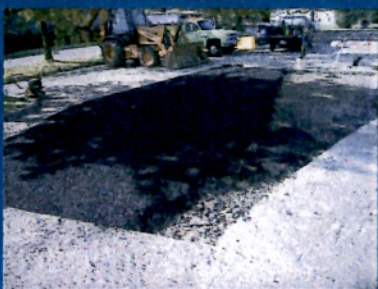
Installing asphalt.

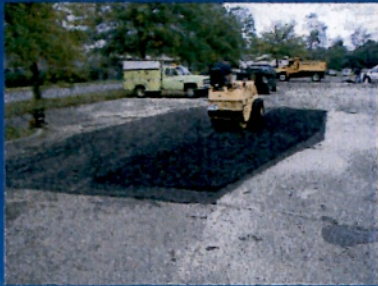
Rolling Asphalt

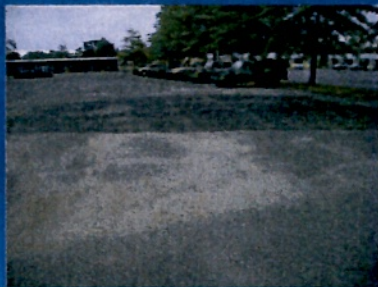
Completed site.
