Underground Storage Tank Closure and Site Investigation Report

Charles Wood – Building 2030

NJDEP UST Registration No.: 192486-11
UST No.: 192486-11

September 2010

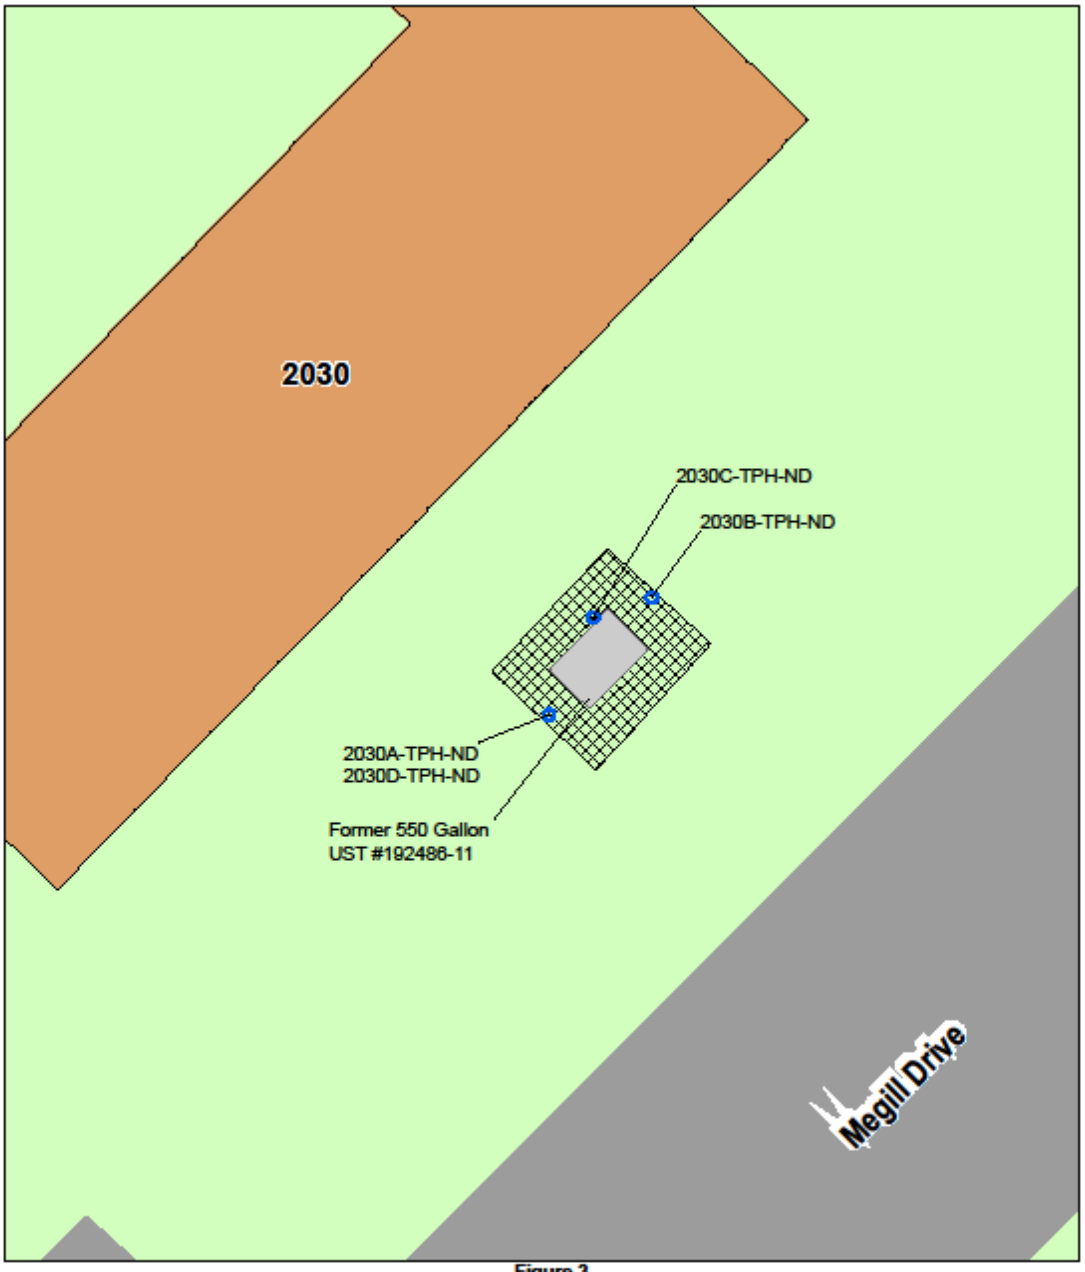
2030
2030C-TPH-ND
2030B-TPH-ND
2030A-TPH-ND
2030D-TPH-ND
Former 550 Gallon
UST #192486-11
Megill Drive
Legend
UST
UST Excavation Limits
Soil Sample - 2/28/2000
10 5 0 10 Feet
N
W E
S
Figure 3
Soil Sampling Location Map
Building 2030, Charles Wood Area
Fort Monmouth, NJ
Date: 1/2011
UST Registration # 192486-11
UST Discharge # NA
FOUO
All drawings must be field verified.
Environmental Division, Directorate of Public Works, Fort Monmouth, New Jersey
