Underground Storage Tank Closure and Site Investigation Report

Building 2537
Charles Wood Area

NJDEP UST Registration No. 81515-27
Dicar No. 97-5-27-1421-04

April 1998

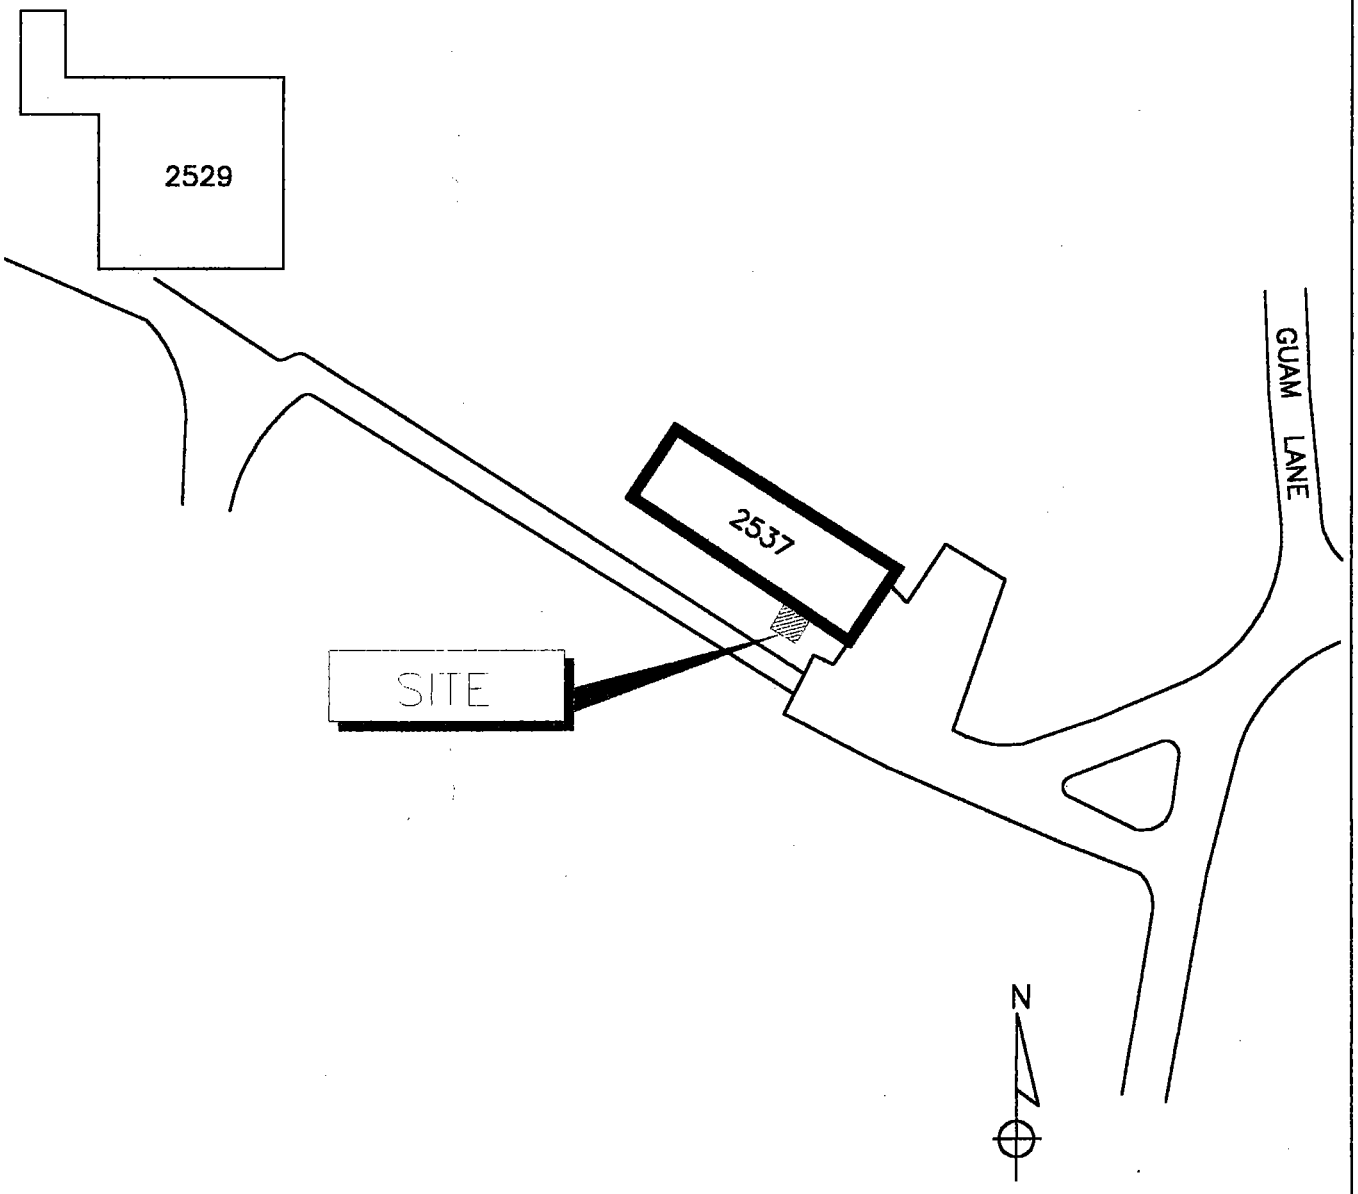
FIGURE 2
SITE MAP
BUILDING 2537
FORT MONMOUTH ARMY BASE
MONMOUTH COUNTY, NJ

Building 2537 is located in the Charles Wood area of the Fort Monmouth Army Base. UST No. 81515-27 was located south of Building 2537 and appurtenant copper piping ran approximately thirty feet east from the excavation to Building 2537. A site map is provided on Figure 2.

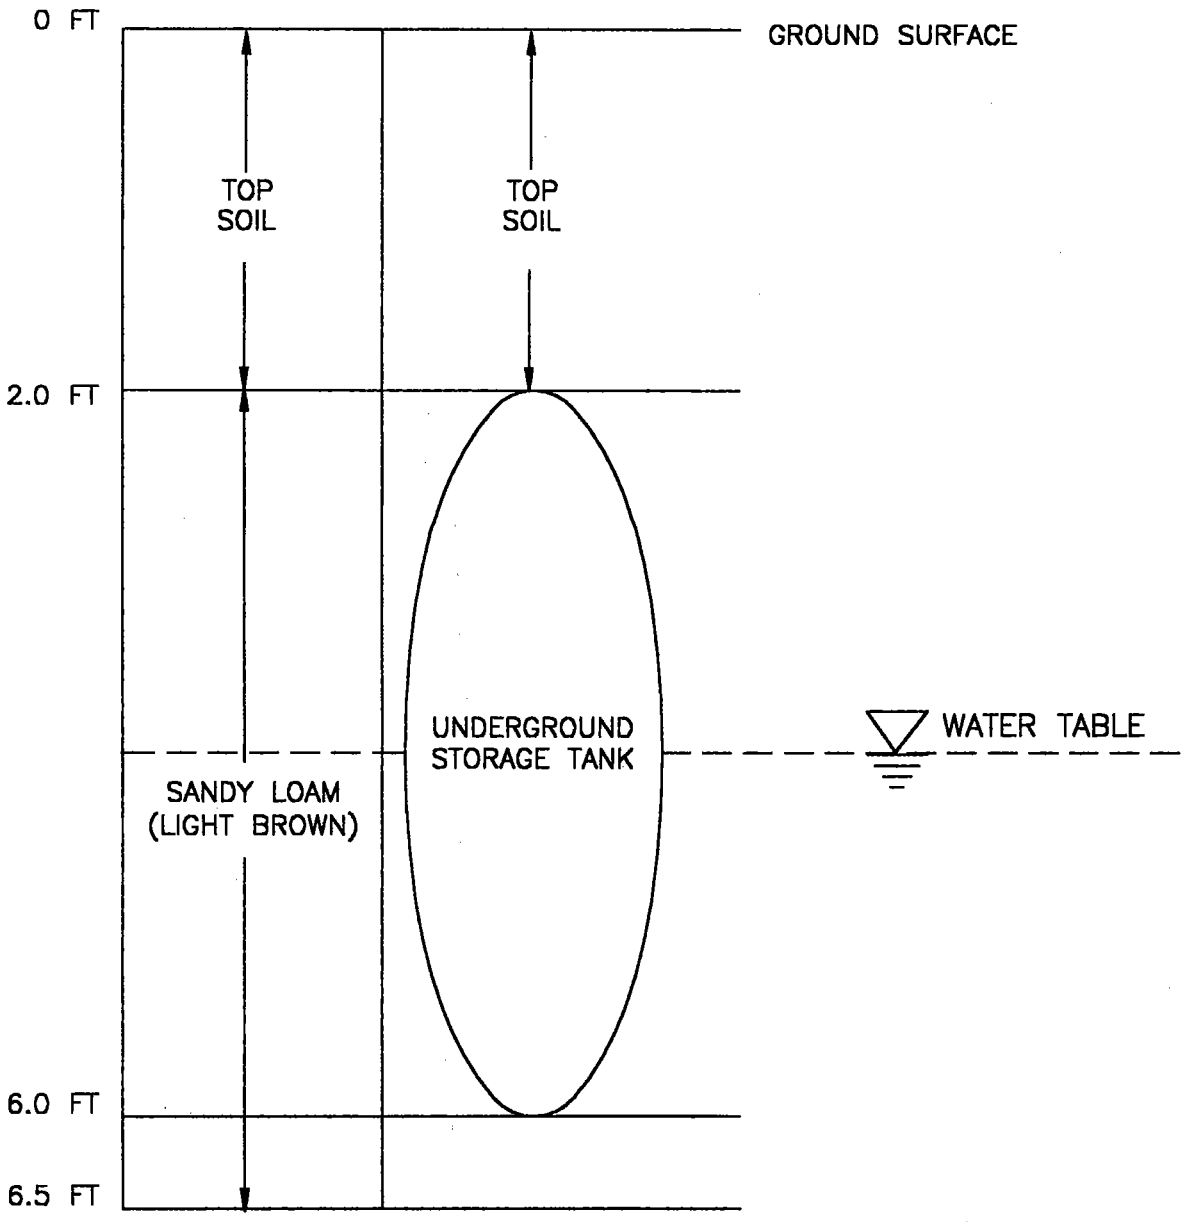
FIGURE 3
CROSS SECTIONAL VIEW
BUILDING 2537
FORT MONMOUTH ARMY BASE
MONMOUTH COUNTY, NJ

One hole was observed during the inspection by the Sub-Surface Evaluator. Soils were screened visually and with an OVA for evidence of contamination. Stained soil was noted in the excavation area. Soil screening was also performed along the piping run associated with the UST closure. No contamination was noted anywhere along the piping length. Perched water was encountered at 3.0 feet bgs and no sheen was observed on the groundwater. See Figure 3 for a cross-sectional view of the excavated area.

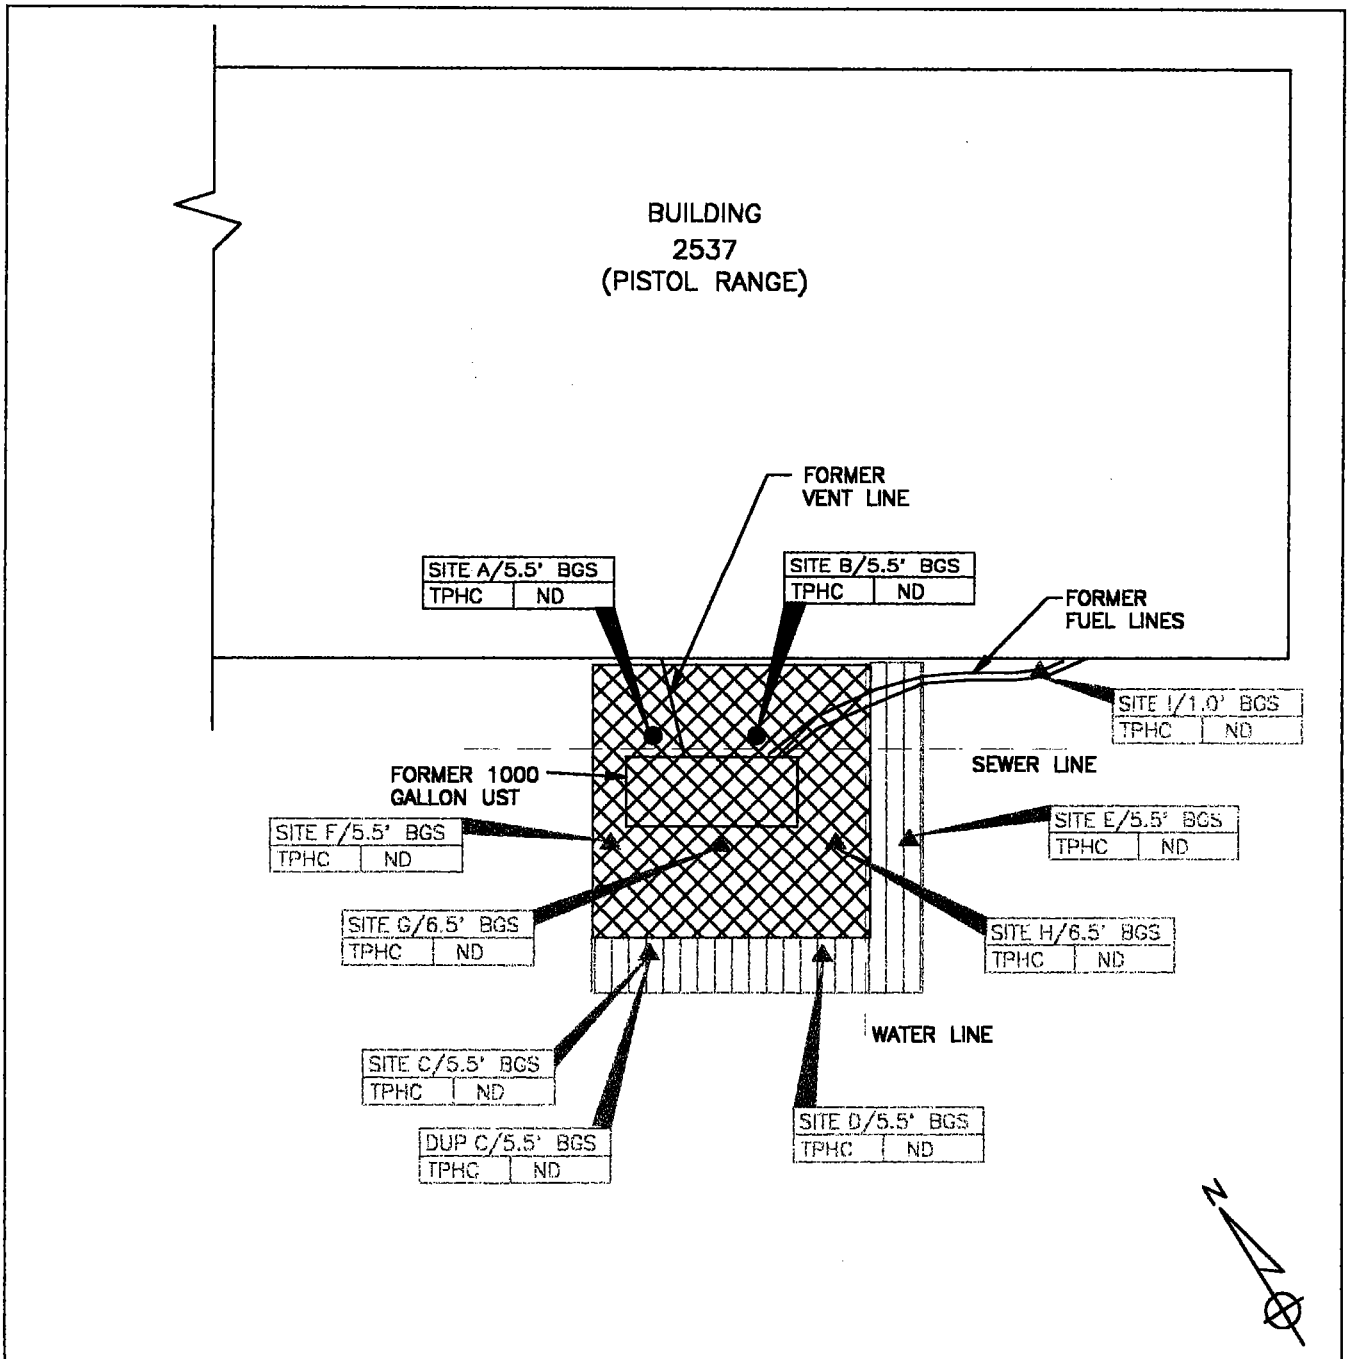
To evaluate soil conditions following removal of the UST and associated piping, post-excavation soil samples were collected on May 28 and 29, 1997 from a total of nine locations. All samples were analyzed for TPHC and total solids. The post-excavation sampling results were compared to the NJDEP residential direct contact total organic contaminants soil cleanup criteria of 10,000 mg/kg (N.J.A.C. 7:26D and revisions dated February 3, 1994). A summary of the analytical results and comparison to the NJDEP criteria is provided in Table 2 and the soil sampling locations are shown on Figure 4. The analytical data package is provided in Appendix E.

All post-excavation soil samples collected on May 28 and 29, from the UST excavation and from below piping associated with the UST contained concentrations of TPHC below the NJDEP soil cleanup criteria. Samples contained levels of non-detectable levels of TPHC.
