Document: "Response to Comments to NJDEP Comments on Final Landfill Boundary Refinement for FTMM-04 only dated January 2016"

SUBJECT: *Final Landfill Boundary Refinement for FTMM-04 only dated January 2016*
Fort Monmouth, Oceanport, New Jersey
PIG000000032

Attachment 1 – FTMM-04 Aerial Photograph from 1969

Attachment 2 – FTMM-04 Aerial Photograph from 2016

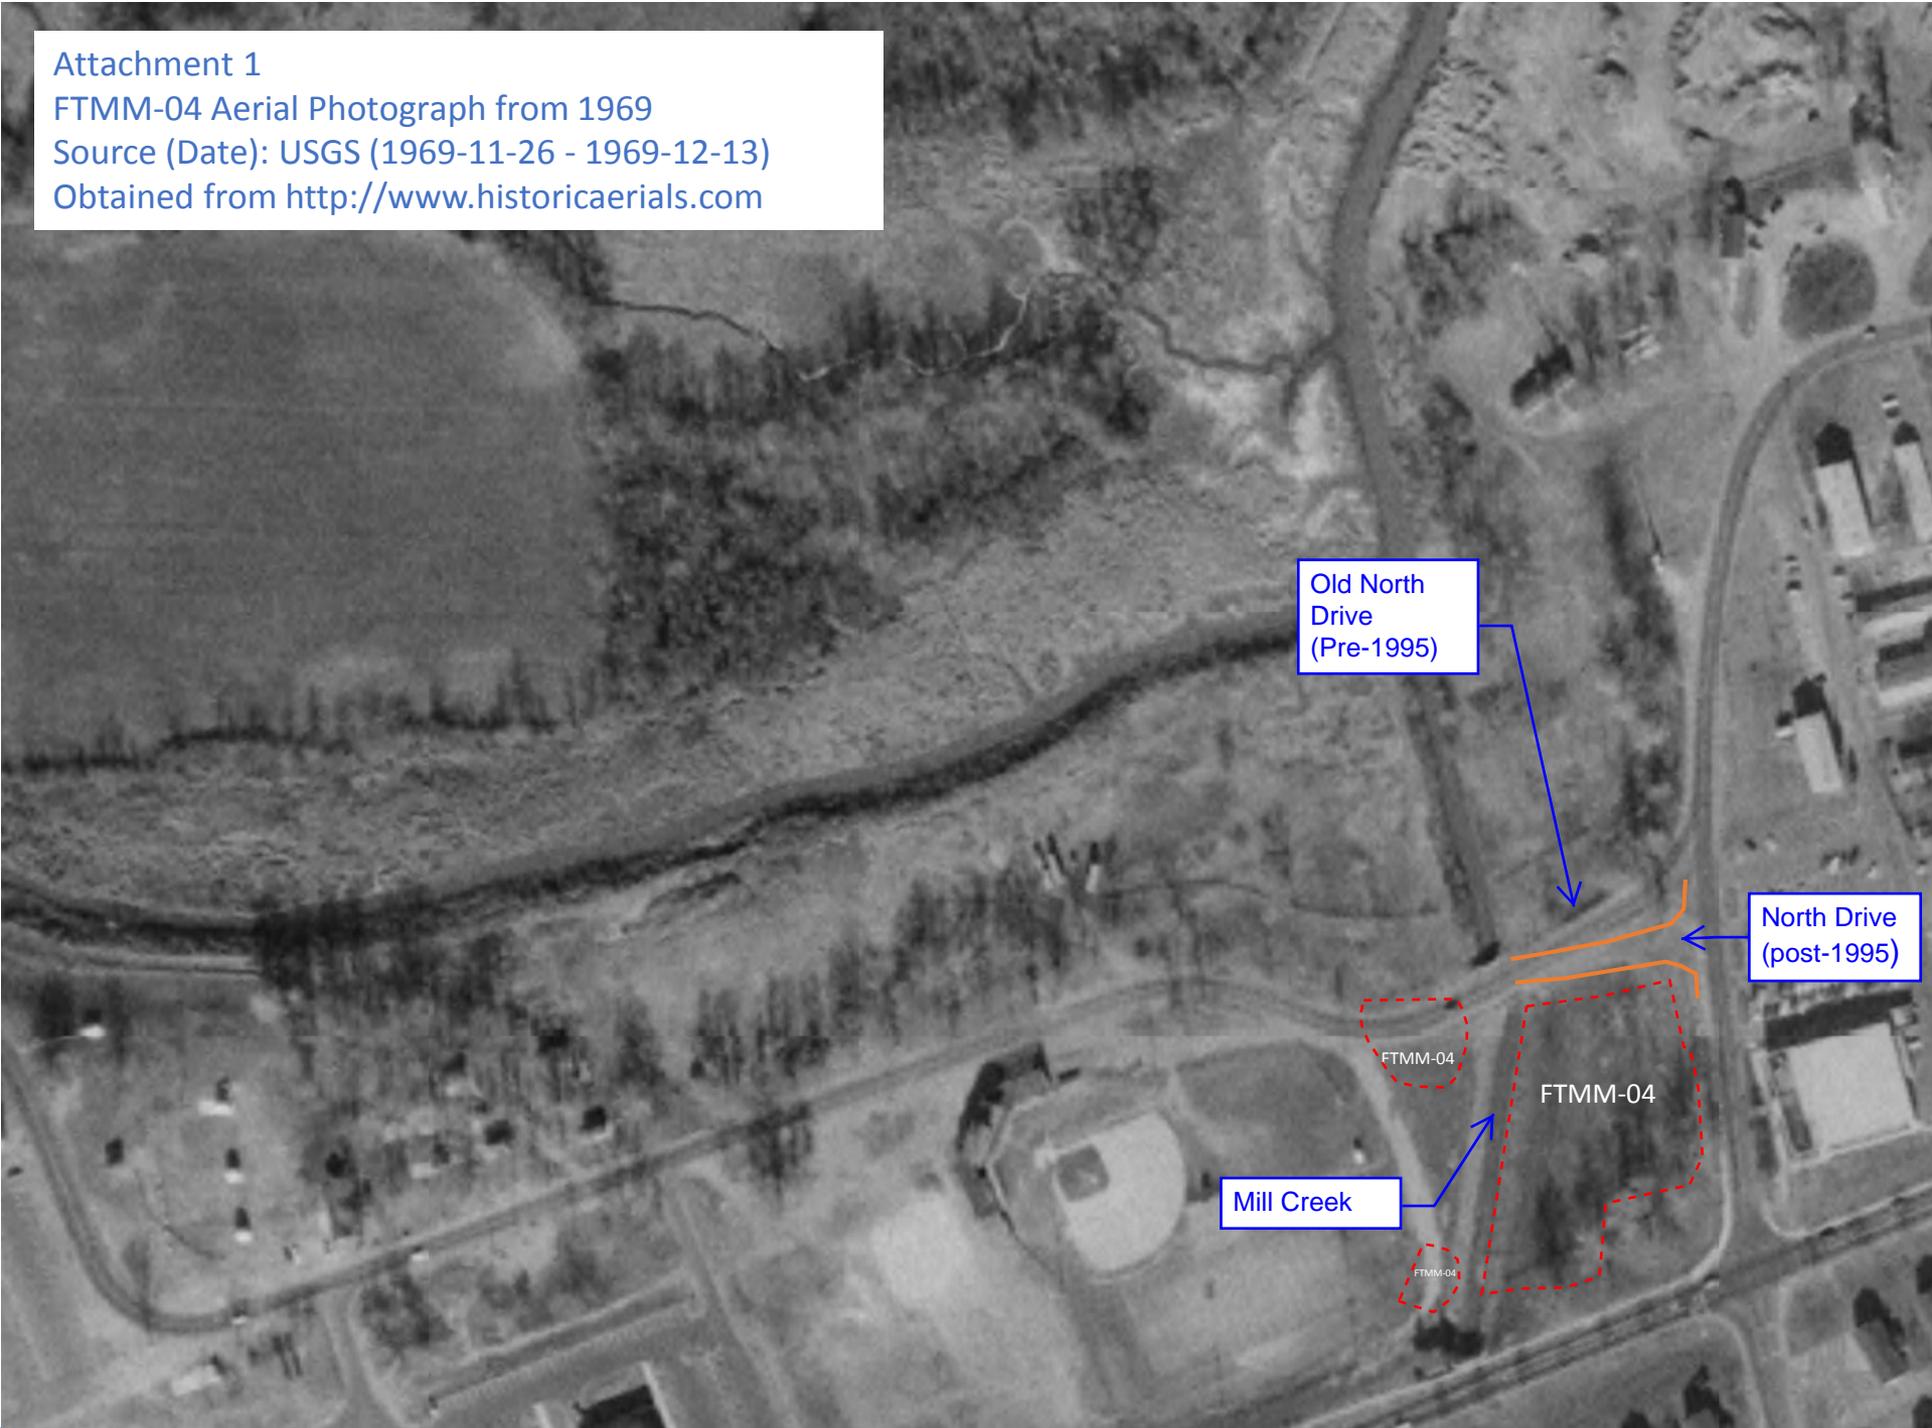
Attachment 1

FTMM-04 Aerial Photograph from 1969

Old North
Drive
(Pre-1995)

North Drive
(post-1995)

Mill Creek

The FTMM team reviewed aerial photographs for FTMM-04 and concurs that North Drive was repositioned along the northern side of the landfill. Based on the aerial photographs, North Drive is currently positioned farther south near its intersection with Wilson Avenue (a change that occurred between 1995 and 2002 based on Google Earth imagery). As a comparison, an aerial photograph from 1969 is included as **Attachment 1** and an aerial photograph from 2016 is included as **Attachment 2**.

Landfill FTMM-04 has been inactive since 1956. Since the repositioning of North Drive occurred subsequent to the closing of FTMM-04, the current location of North Drive covers the northern portion of FTMM-04 and does not impact the landfill boundaries. FTMM believes that the existing information (test pits 6, M4TP16, and M4TP17) confirms the northern extent of landfill material at FTMM-04 and additional confirmation of the northern boundary is not required.

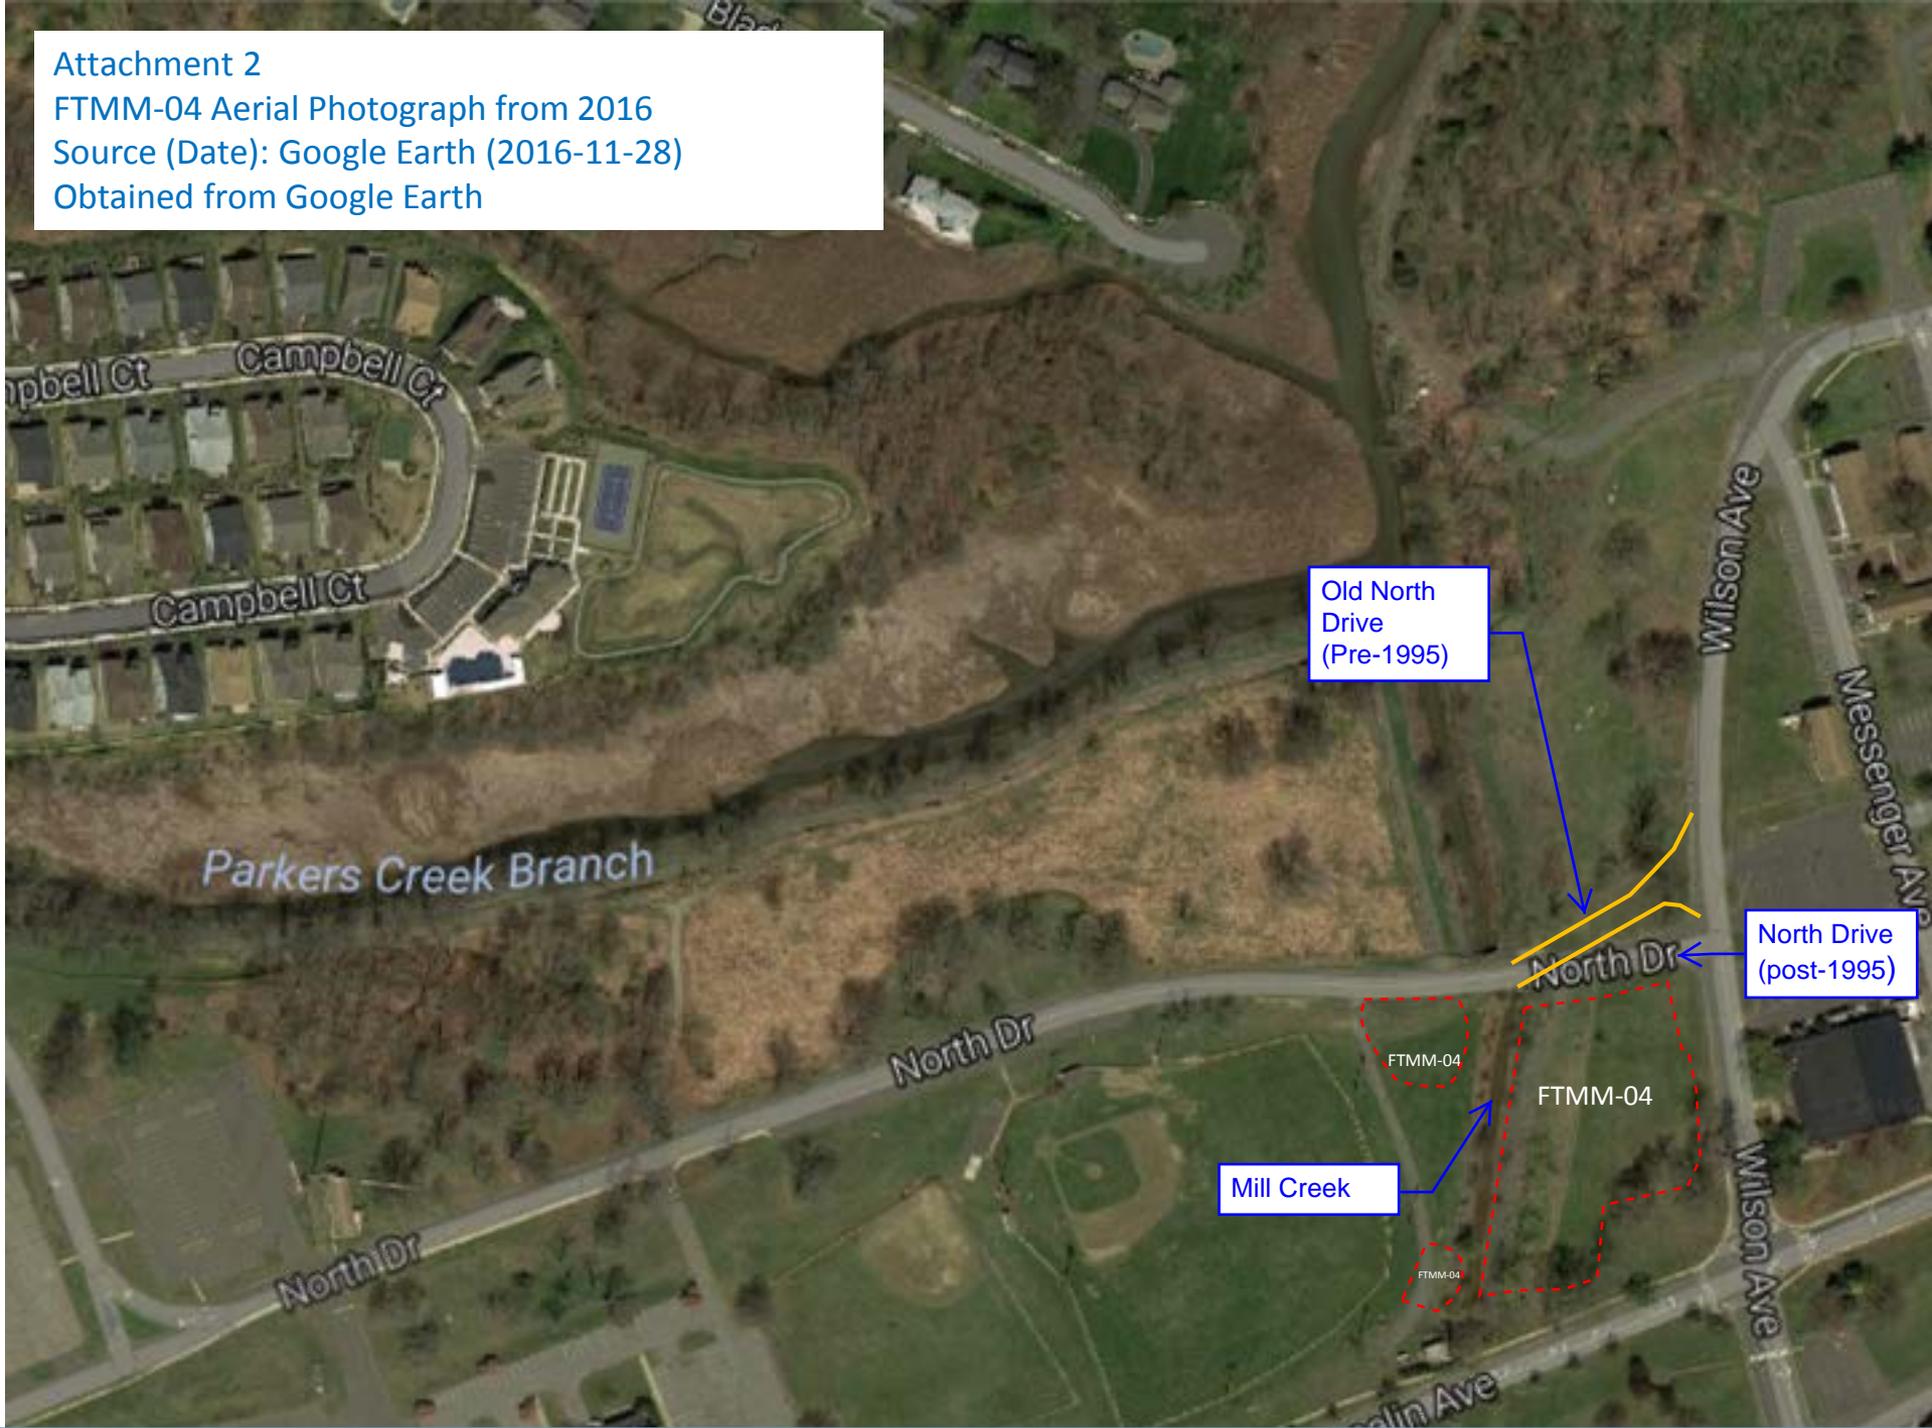
Attachment 2

FTMM-04 Aerial Photograph from 2016

Old North Drive
(Pre-1995)

North Drive
(post-1995)

Mill Creek
