**Underground Storage Tank
Closure and Site Investigation
Report**

***Building 410
Main Post-East Area***

NJDEP UST Registration No. 90010-27

December 1997

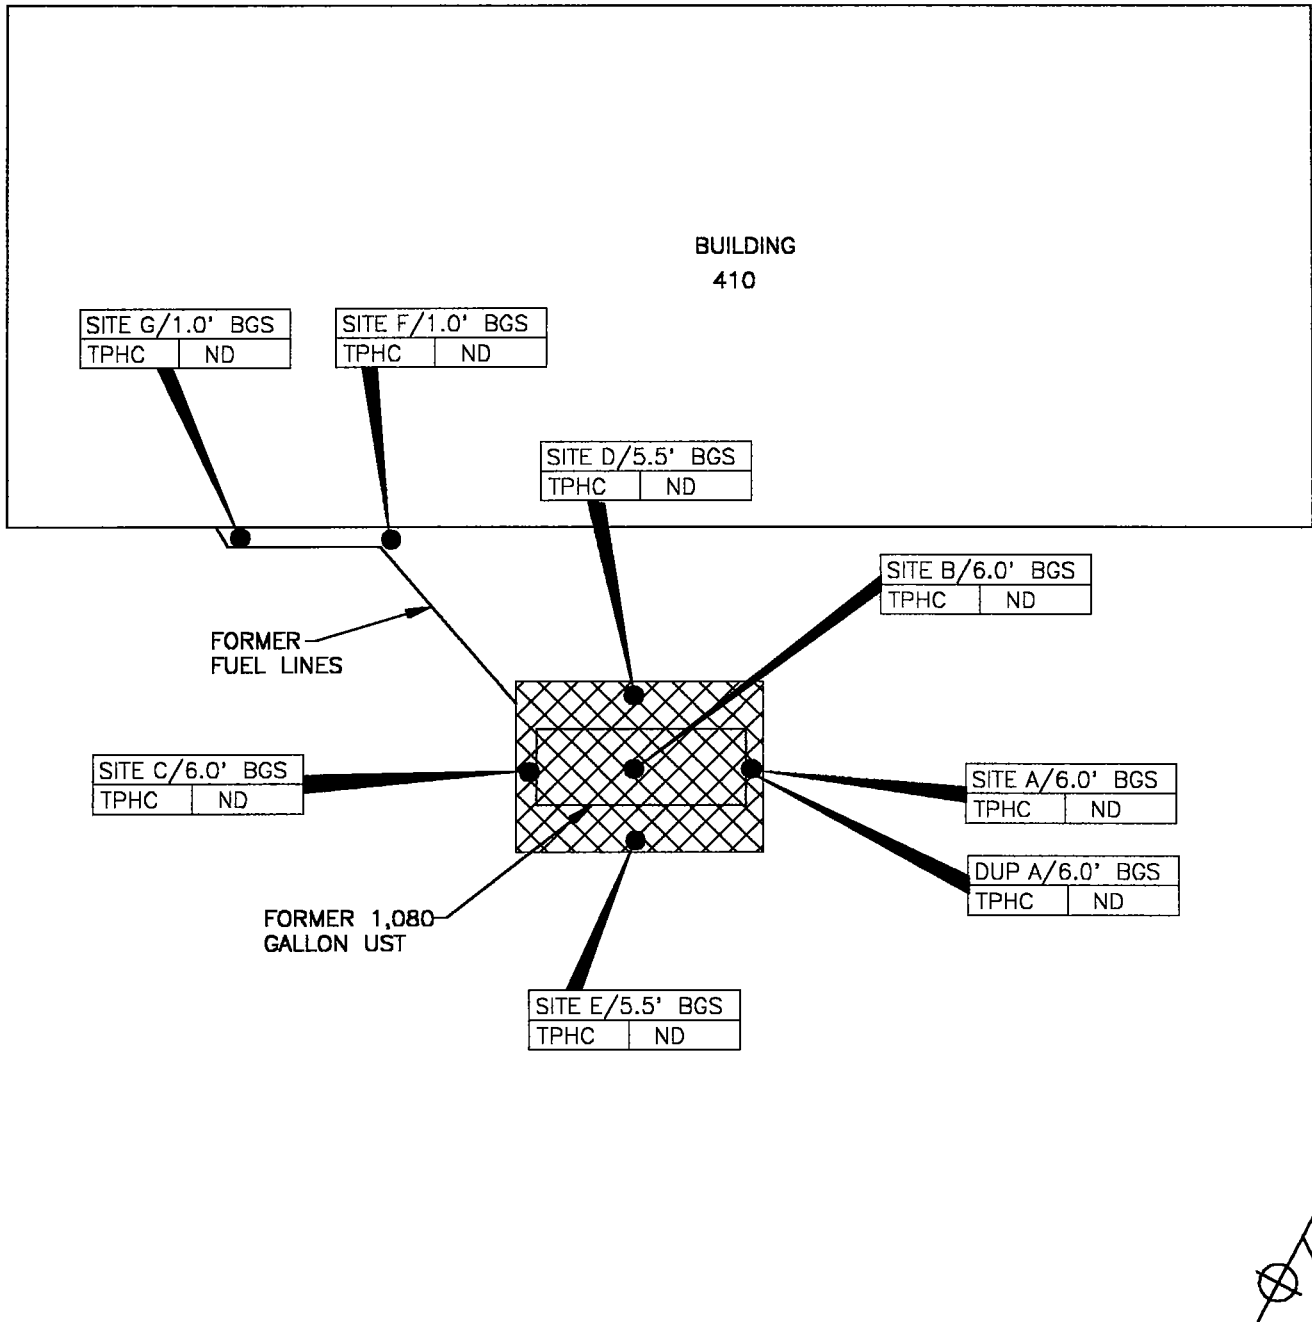
FIGURE 4
SOIL SAMPLING LOCATION MAP
BUILDING 410
FORT MONMOUTH ARMY BASE
MONMOUTH COUNTY, NJ

To evaluate soil conditions following removal of the UST and associated piping, post-excavation soil samples were collected on May 14, 1997 from a total of seven (7) locations. All samples were analyzed for TPHC and total solids. The post-excavation sampling results were compared to the NJDEP residential direct contact total organic contaminants soil cleanup criteria of 10,000 mg/kg (N.J.A.C. 7:26D and revisions dated February 3, 1994). A summary of the analytical results and comparison to the NJDEP soil cleanup criteria is provided in Table 2 and the soil sampling locations are shown on Figure 4. The analytical data package is provided in Appendix E.

All post-excavation soil samples collected on May 14, 1997, from the UST excavation and from below piping associated with the UST contained concentrations of TPHC below the NJDEP soil cleanup criteria. Samples contained non-detectable TPHC levels.

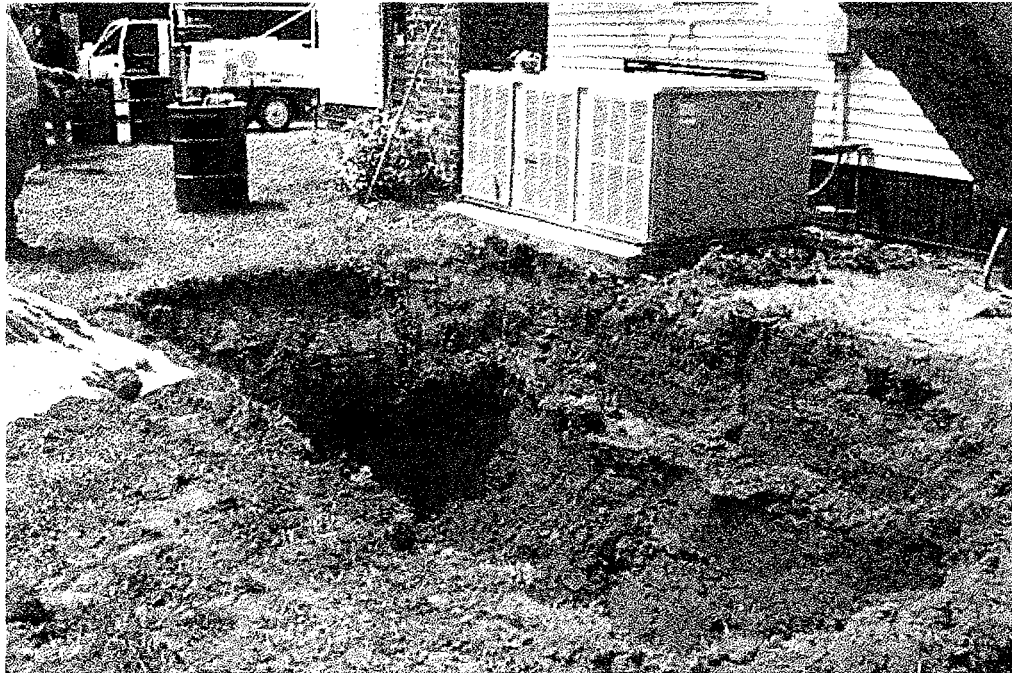
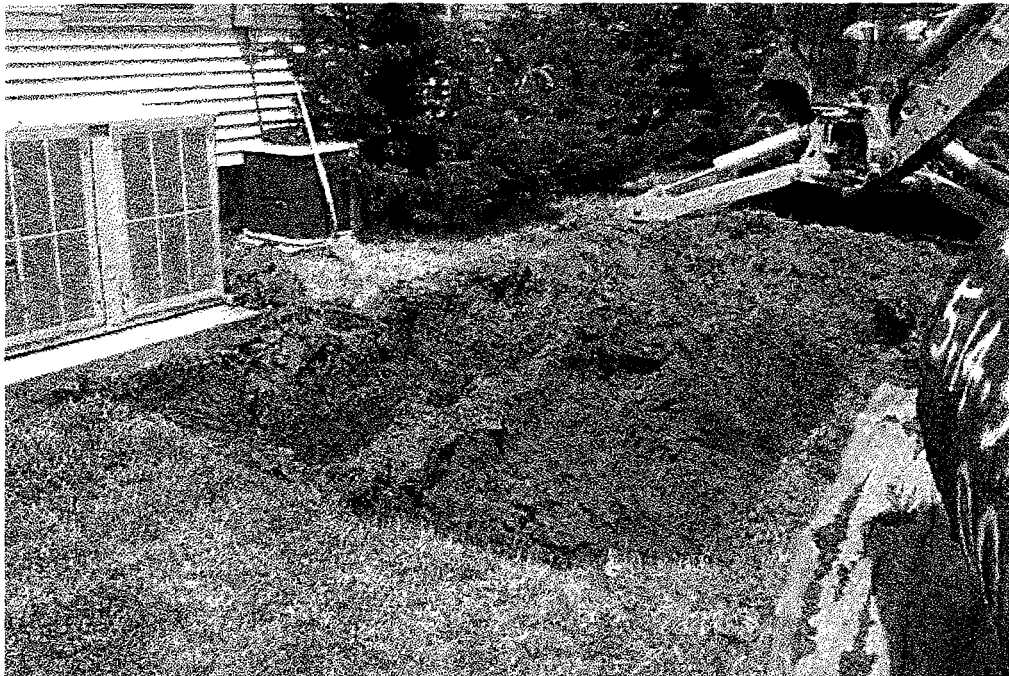
PHOTOGRAPHIC LOG

The tar-coated steel tank was transported to Mazza & Sons, Inc., Recycling Division in compliance with all applicable regulations and laws. See Appendix D for the UST Disposal Certificate and Appendix F for photographs of the UST.
