**Underground Storage Tank
Closure and Site Investigation
Report**

***Building 427
Main Post-East Area***

NJDEP UST Registration No. 90010-41

December 1997

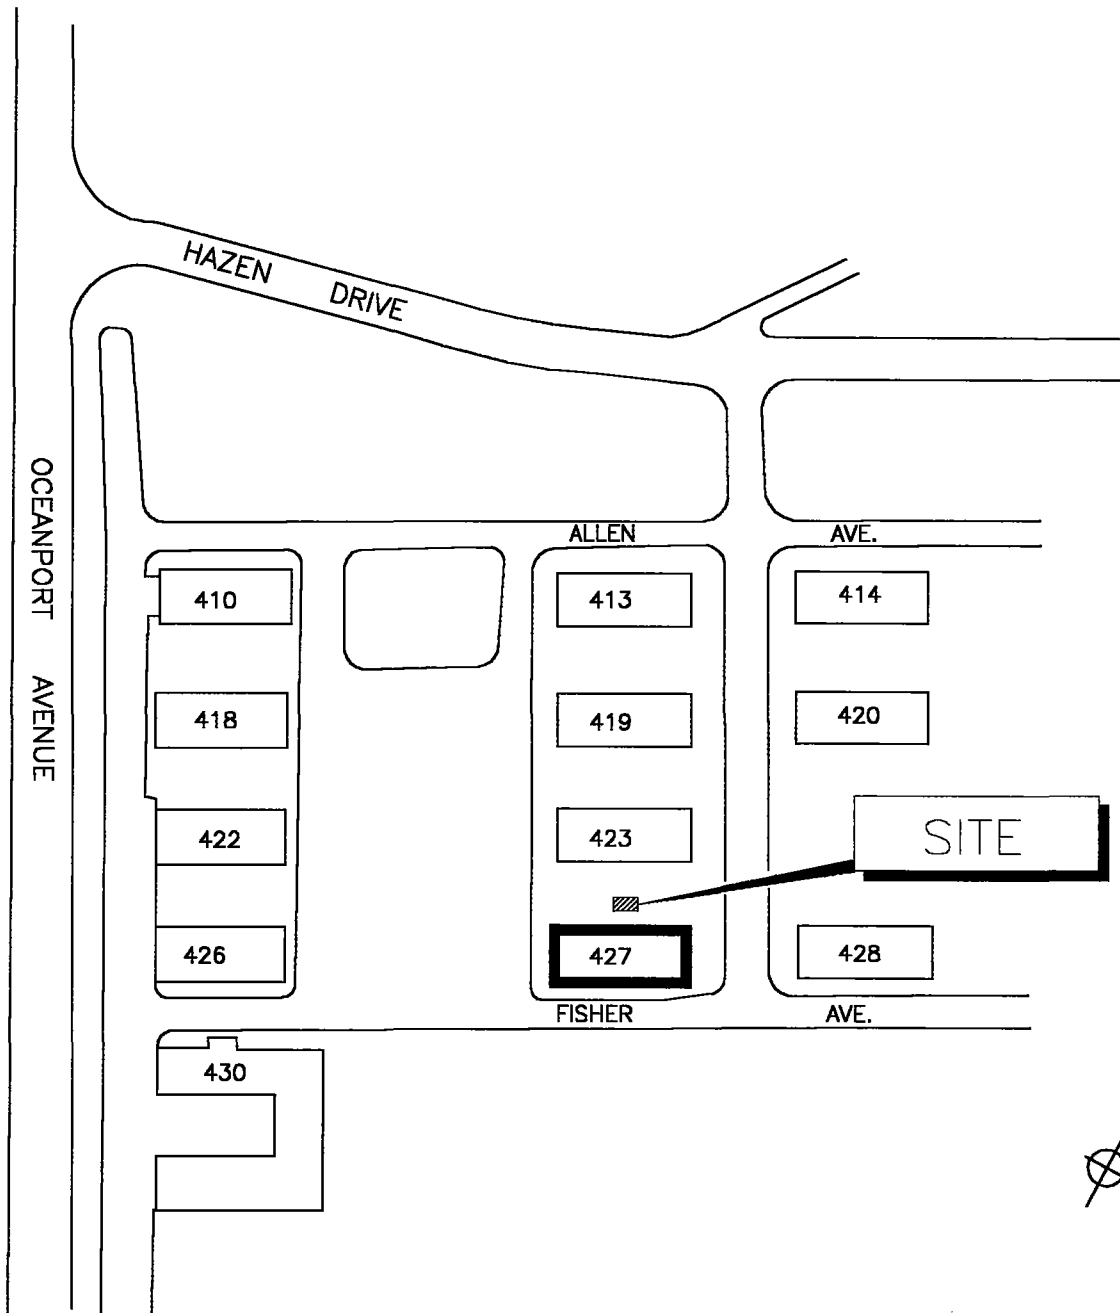
FIGURE 2
 SITE MAP
 BUILDING 427
 FORT MONMOUTH ARMY BASE
 MONMOUTH COUNTY, NJ

Building 427 is located in the Main Post-East area of the Fort Monmouth Army Base. UST No. 90010-41 was located north of Building 427. Appurtenant copper piping was approximately twenty (20) feet in length and ran southeast ten (10) feet and then east ten (10) feet to Building 427. A site map is provided on Figure 2.
