**Underground Storage Tank
Closure and Site Investigation
Report**

***Building 430A
Main Post-East Area***

NJDEP UST Registration No. 90010-44

December 1997

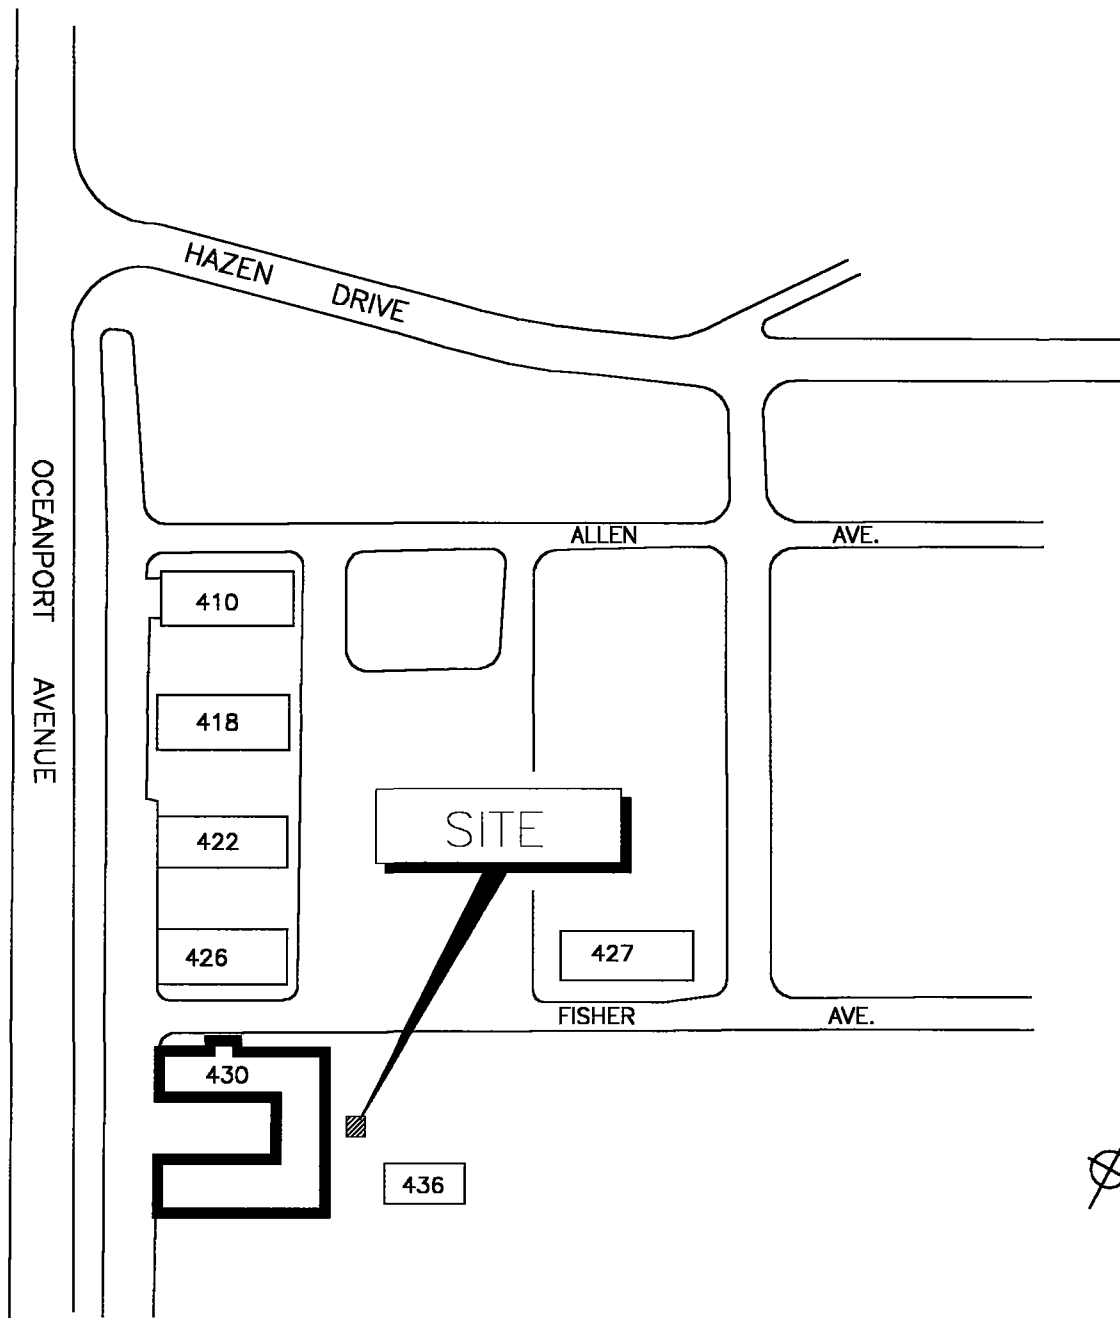
FIGURE 2
 SITE MAP
 BUILDING 430A
 FORT MONMOUTH ARMY BASE
 MONMOUTH COUNTY, NJ

Building 430A is located in the Main Post-East area of the Fort Monmouth Army Base. UST No. 90010-44 was located east of Building 430A. Appurtenant copper piping was approximately twelve (12) feet in length and ran west to Building 430A. A site map is provided on Figure 2.

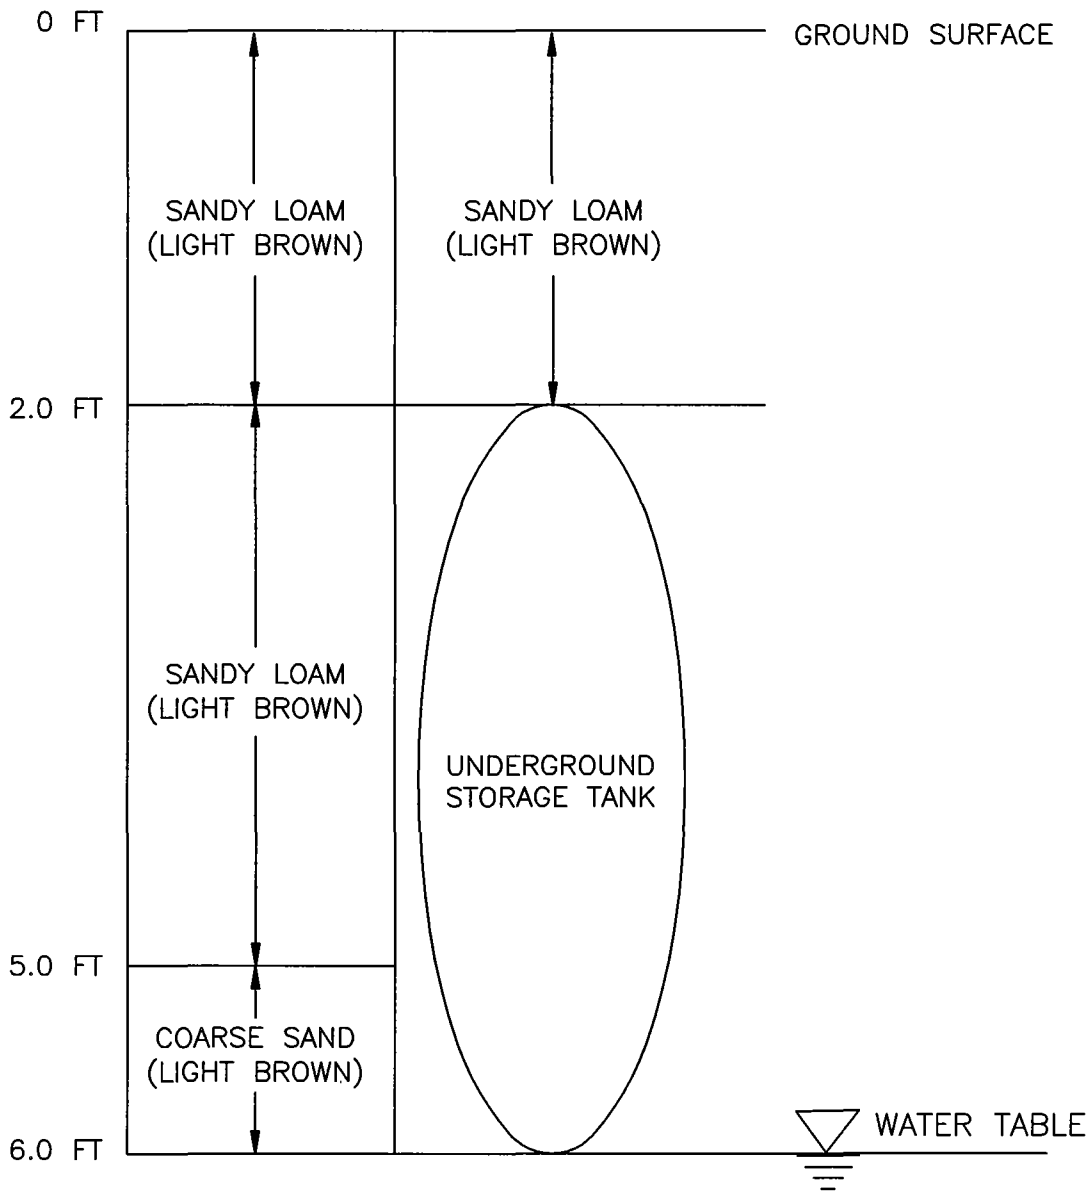
FIGURE 3
 CROSS SECTIONAL VIEW
 BUILDING 430A
 FORT MONMOUTH ARMY BASE
 MONMOUTH COUNTY, NJ

After the UST was cleaned, it was staged on polyethylene sheeting and examined for holes. No holes were observed during the inspection by the Sub-Surface Evaluator. Soils surrounding the UST were screened visually and with an OVA for evidence of contamination. No evidence of contamination was observed. Soil screening was also performed along the piping run associated with the UST closure. No contamination was noted anywhere along the piping length. Groundwater was encountered at 6.0 feet bgs and a sheen was not observed. See Figure 3 for a cross-sectional view of the excavated area.

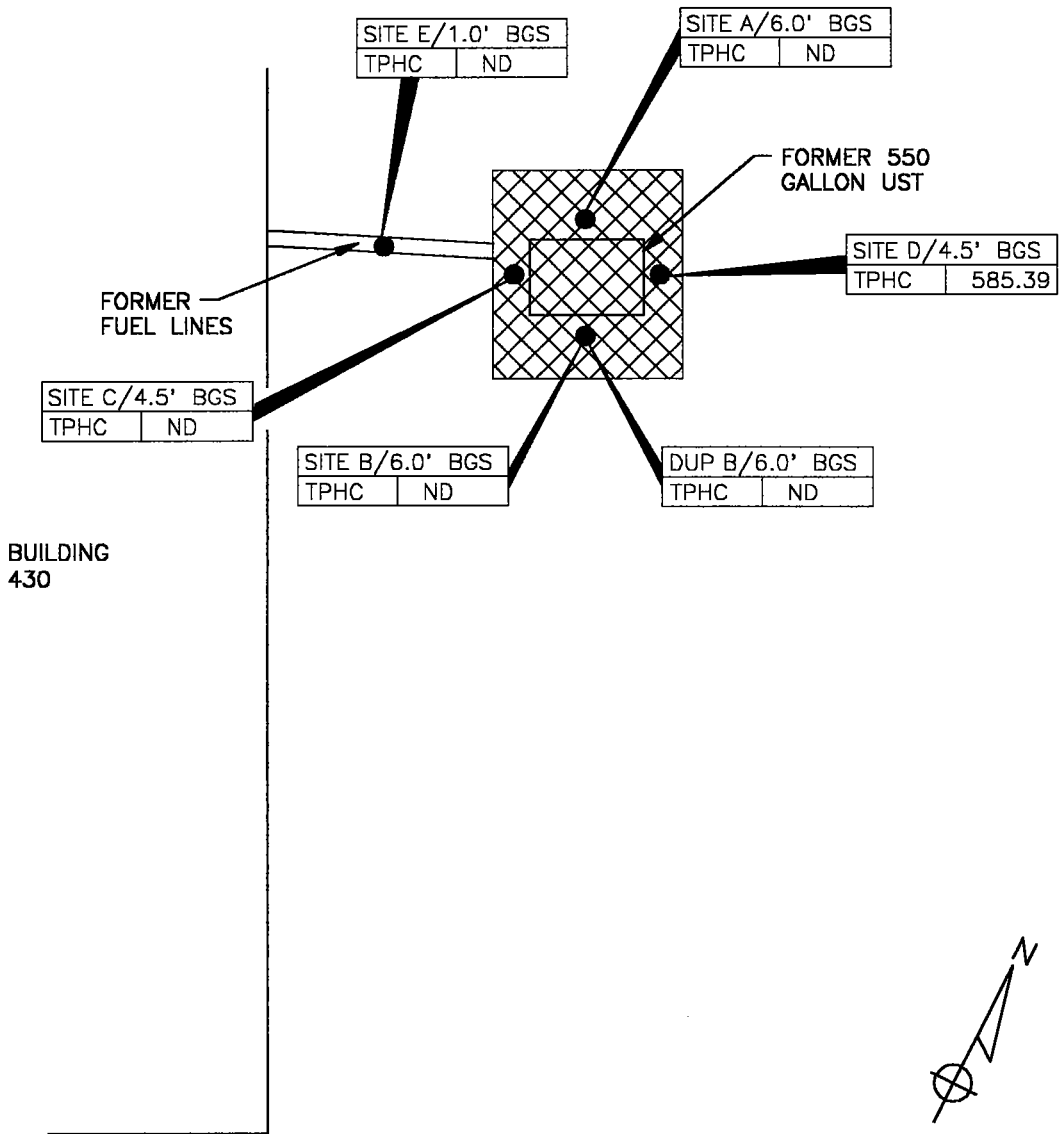
FIGURE 4
 SOIL SAMPLING LOCATION MAP
 BUILDING 430A
 FORT MONMOUTH ARMY BASE
 MONMOUTH COUNTY, NJ

To evaluate soil conditions following removal of the UST and associated piping, post-excavation soil samples were collected on May 19, 1997 from a total of five (5) locations. All samples were analyzed for TPHC and total solids. The post-excavation sampling results were compared to the NJDEP residential direct contact total organic contaminants soil cleanup criteria of 10,000 mg/kg (N.J.A.C. 7:26D and revisions dated February 3, 1994). A summary of the analytical results and comparison to the NJDEP soil cleanup criteria is provided in Table 2 and the soil sampling locations are shown on Figure 4. The analytical data package is provided in Appendix E.

All post-excavation soil samples collected on May 19, 1997, from the UST excavation and from below piping associated with the UST contained concentrations of TPHC below the NJDEP soil cleanup criteria. Samples contained TPHC concentrations ranging from non-detected to 585.39 mg/kg.

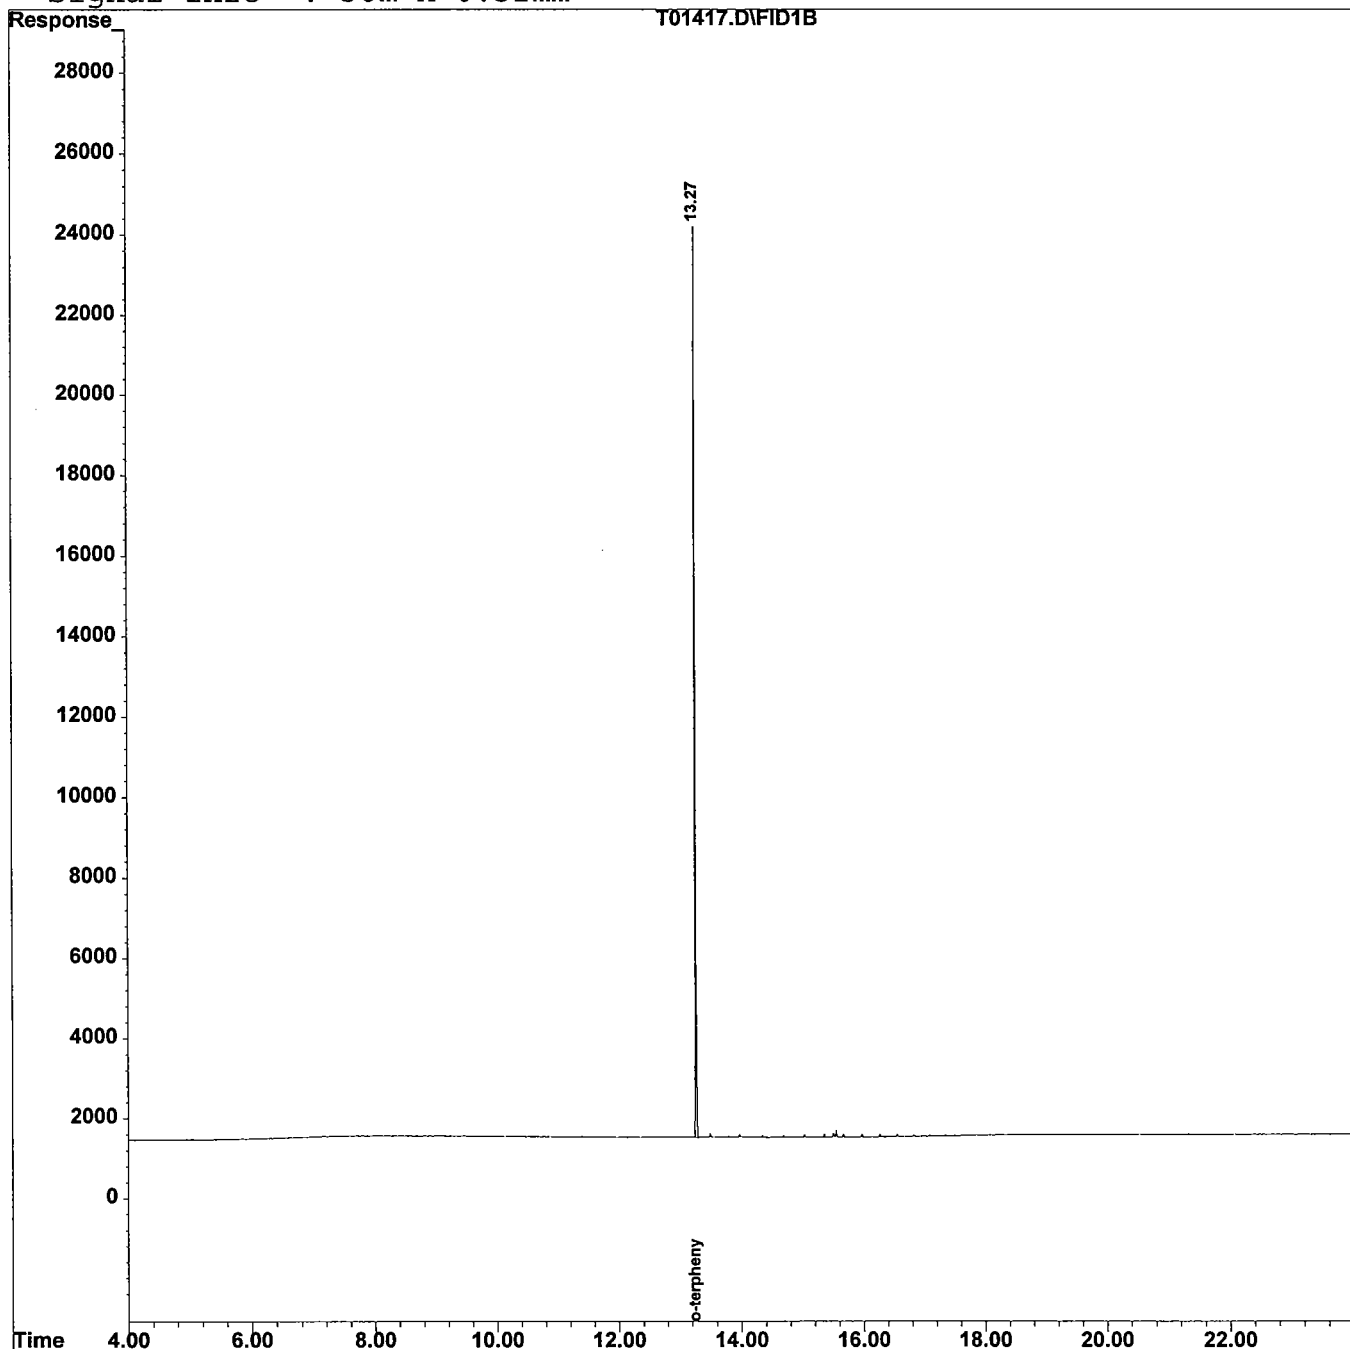
Data File : C:\HPCHEM\1\DATA\970520\T01418.D Vial: 36
 Acq On : 21 May 97 9:23 pm Operator:
 Sample : 2571.02 Inst : FID/TCD
 Misc : Multiplr: 1.00
 IntFile : autoint1.e
 Quant Time: Jun 4 10:27 1997 Quant Results File: TPH6.RES

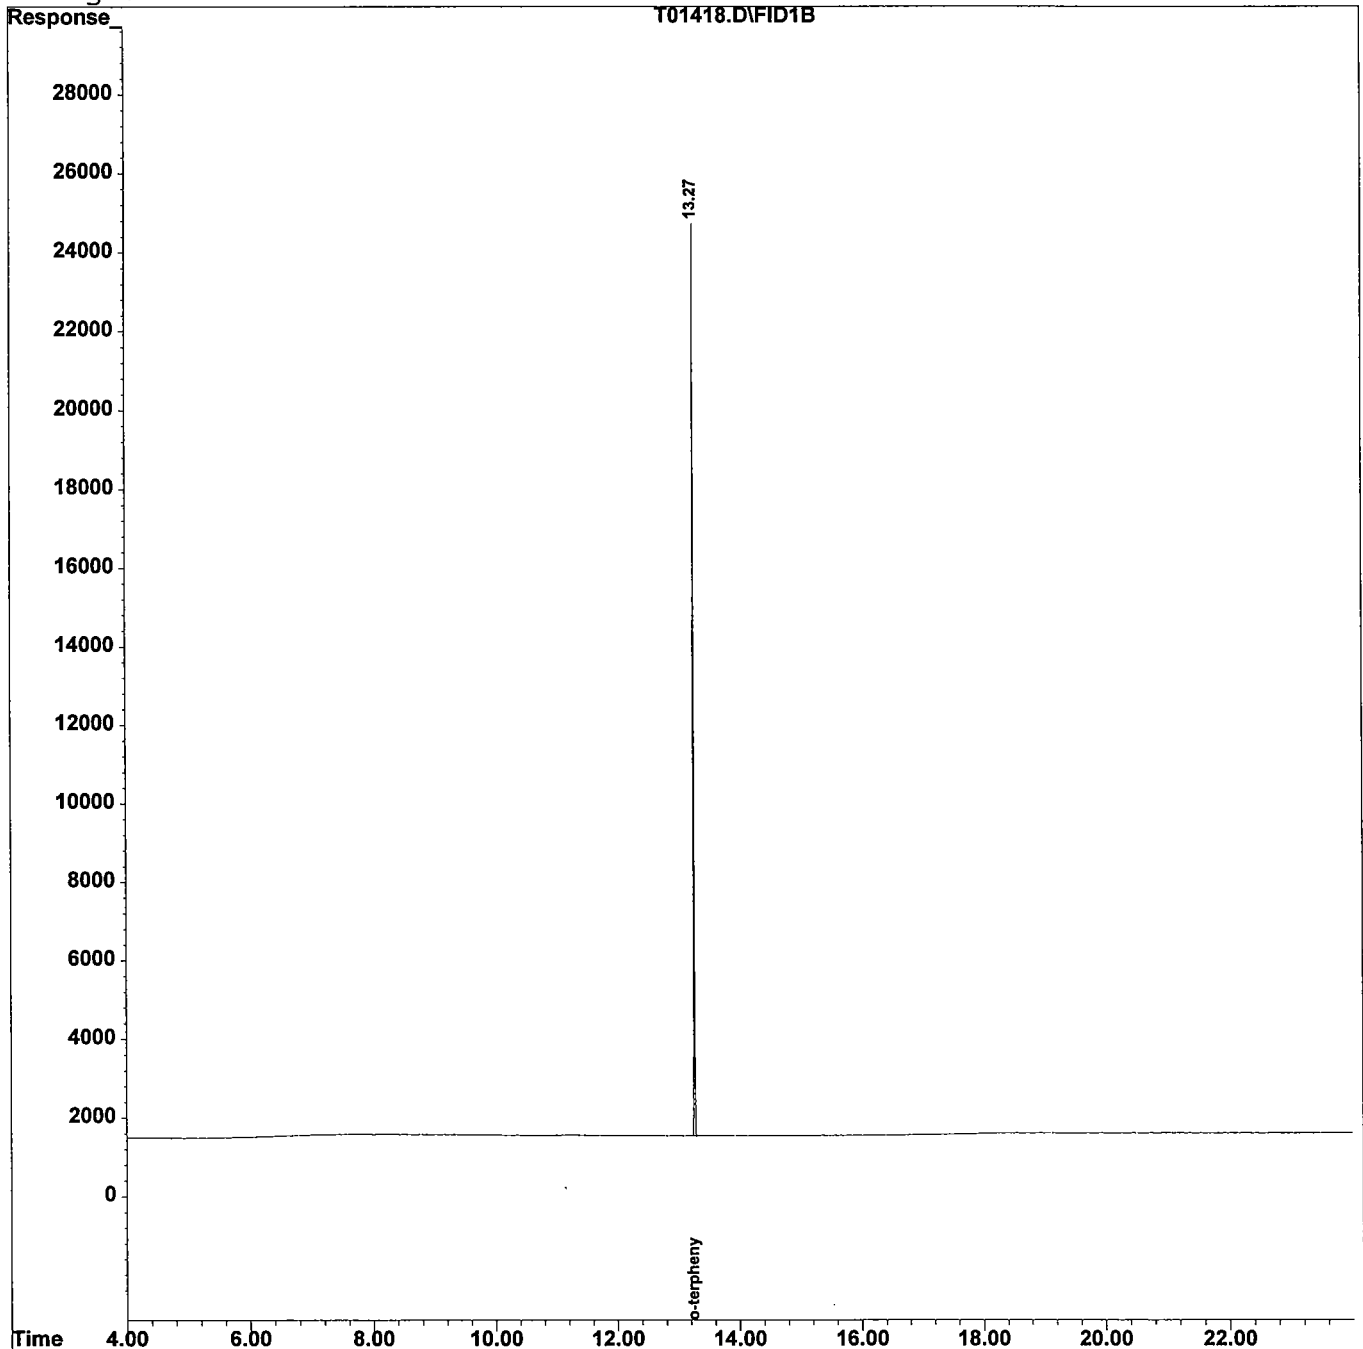
Data File : C:\HPCHEM\1\DATA\970520\T01419.D Vial: 37
 Acq On : 21 May 97 10:07 pm Operator:
 Sample : 2571.03 Inst : FID/TCD
 Misc : Multiplr: 1.00
 IntFile : autoint1.e
 Quant Time: Jun 4 10:27 1997 Quant Results File: TPH6.RES

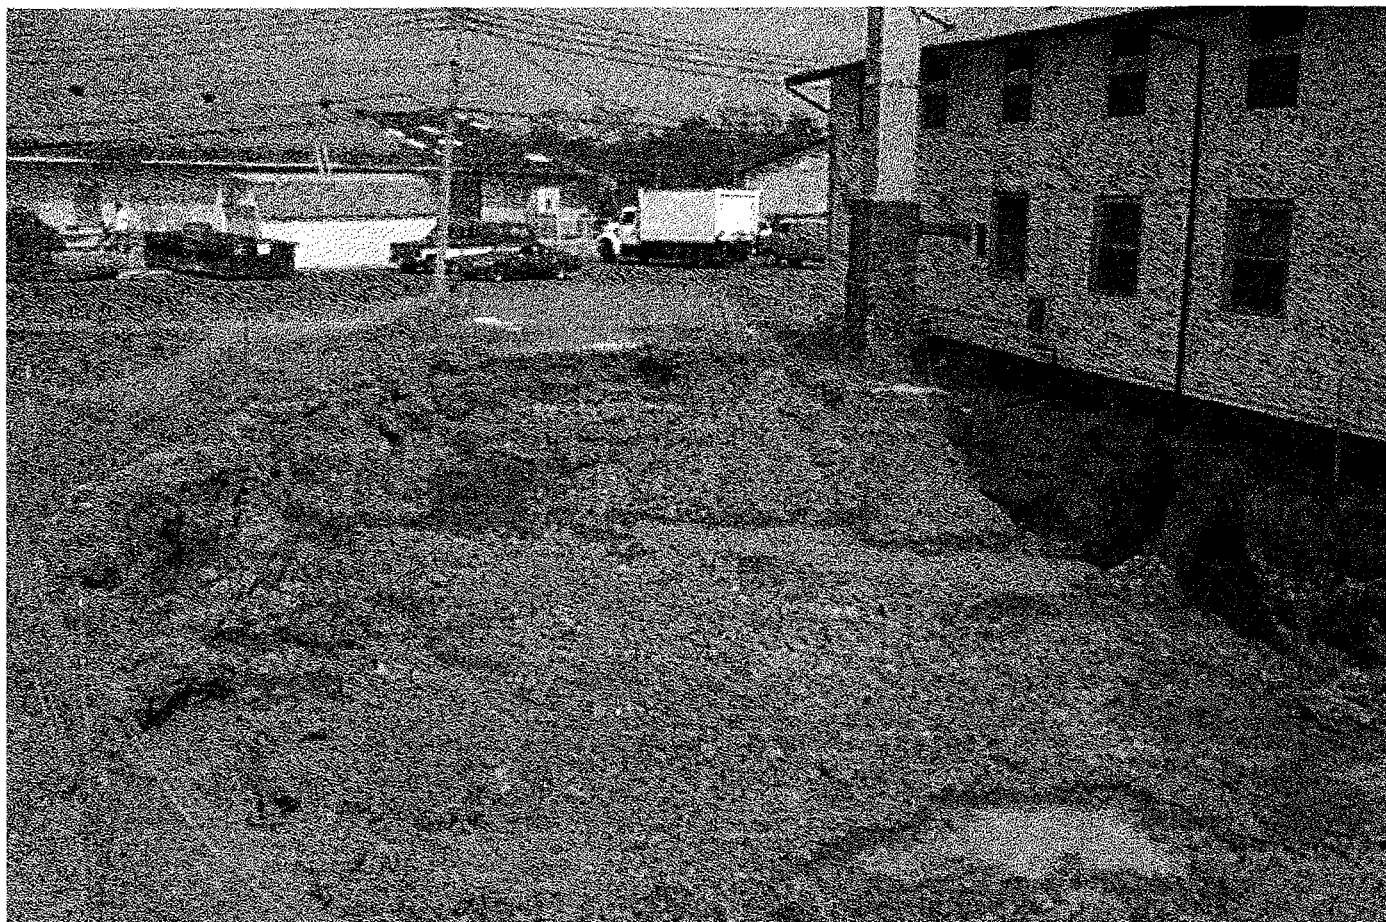
PHOTOGRAPHIC LOG

The tank was transported to Mazza & Sons, Inc., Recycling Division. The transportation of the UST was in compliance with all applicable regulations and laws. See Appendix D for the UST disposal certificate and Appendix F for photographs of the UST.
