**Underground Storage Tank
Closure and Site Investigation
Report**

***Building 900B
Main Post-West Area***

NJDEP UST Registration No. 0081533-142

December 1997

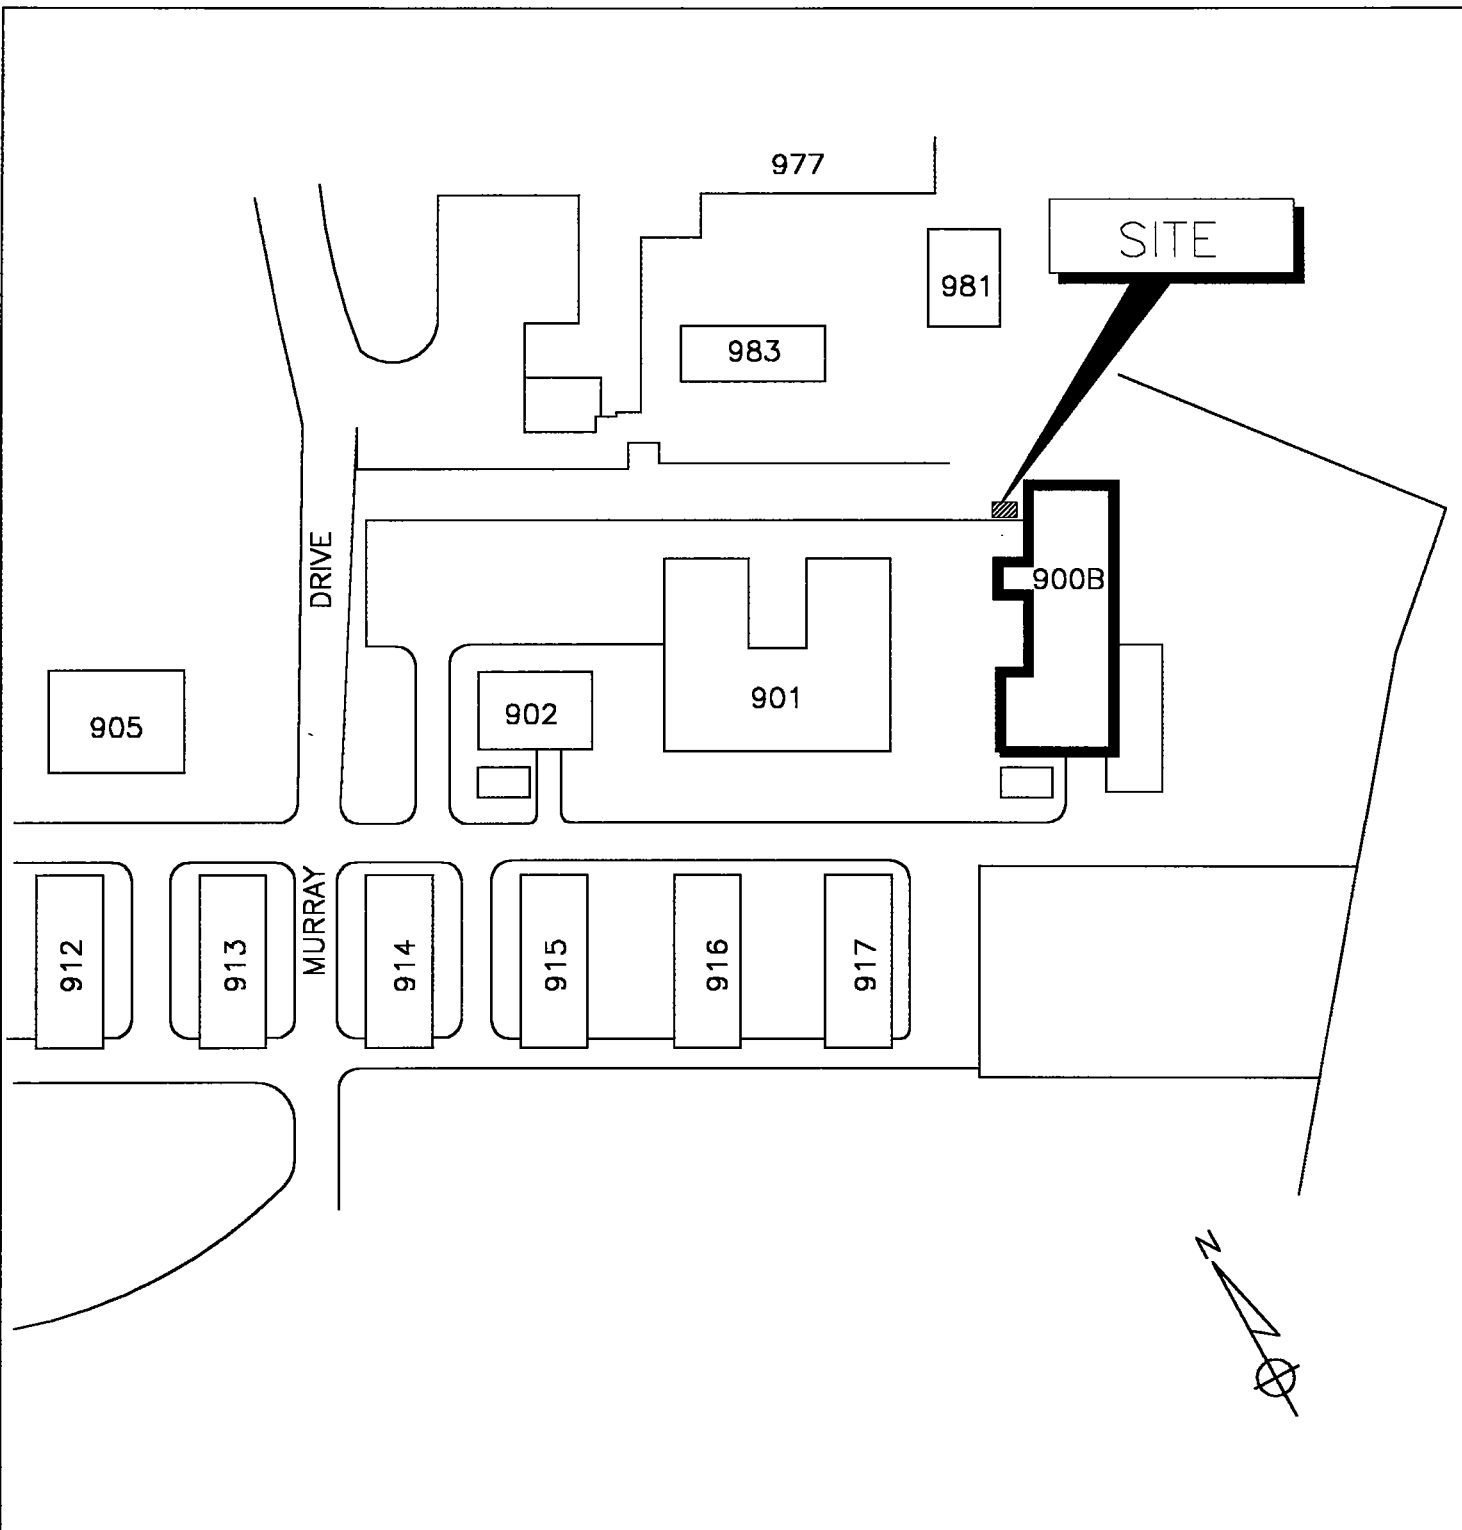
<p>FIGURE 2 SITE MAP BUILDING 900B FORT MONMOUTH ARMY BASE MONMOUTH COUNTY, NJ</p>	
<p>

Building 900B is located in the Main Post-West area of the Fort Monmouth Army Base. UST No. 0081533-142 was located west of Building 900B. Two sets of appurtenant piping were associated with the UST. One pipe run was approximately seven (7) feet in length and ran east to Building 900B. The other piping run was approximately twenty-two (22) feet in length and ran south to Building 900B. A site map is provided on Figure 2.

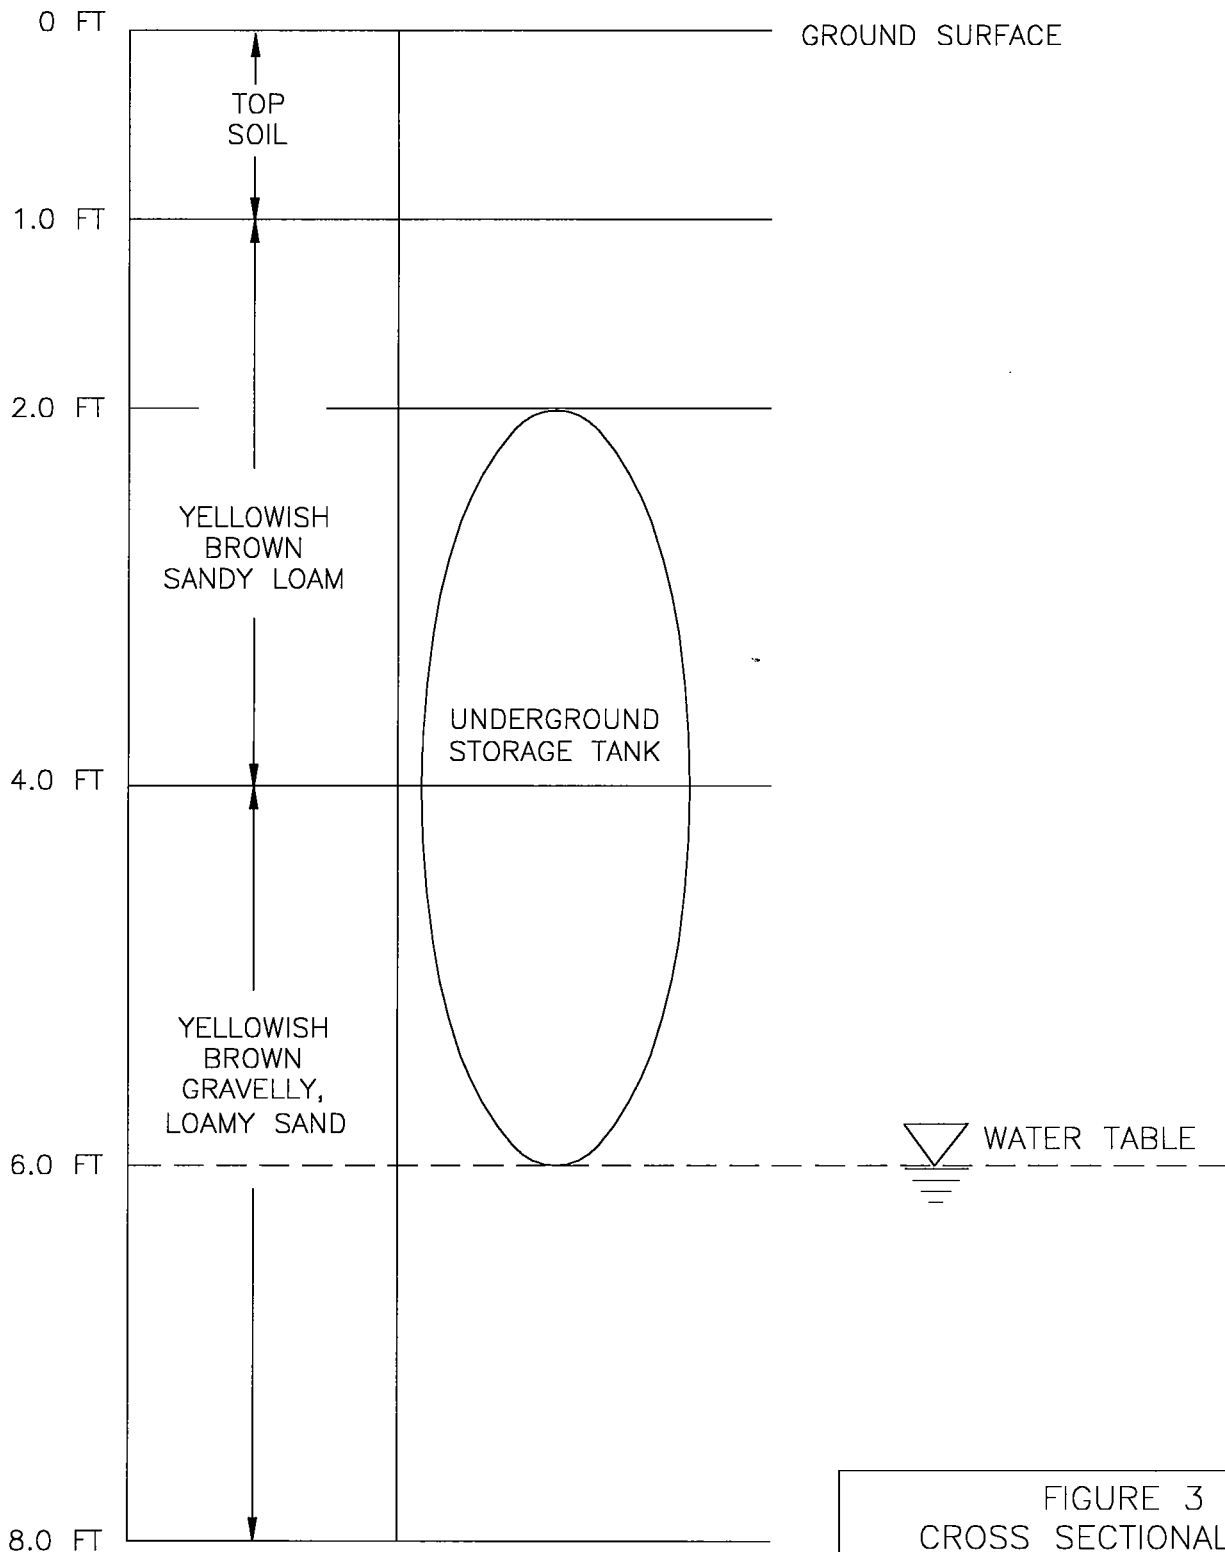
FIGURE 3
 CROSS SECTIONAL VIEW
 BUILDING 900B
 FORT MONMOUTH ARMY BASE
 MONMOUTH COUNTY, NJ

The UST was cleaned prior to removal from the excavation in accordance with the NJDEP-BUST regulations. After the UST was removed from the excavation, it was staged on polyethylene sheeting and examined for holes. No holes or punctures were observed during the inspection by the Sub-Surface Evaluator. Soils surrounding the UST were screened visually and with an OVA for evidence of contamination. No evidence of contamination was observed. Soil screening was also performed along the piping run associated with the UST closure. No contamination was noted anywhere along the piping length. Groundwater was encountered at 6.0 feet bgs. A sheen was not observed on the groundwater. See Figure 3 for a cross-sectional view of the excavated area.

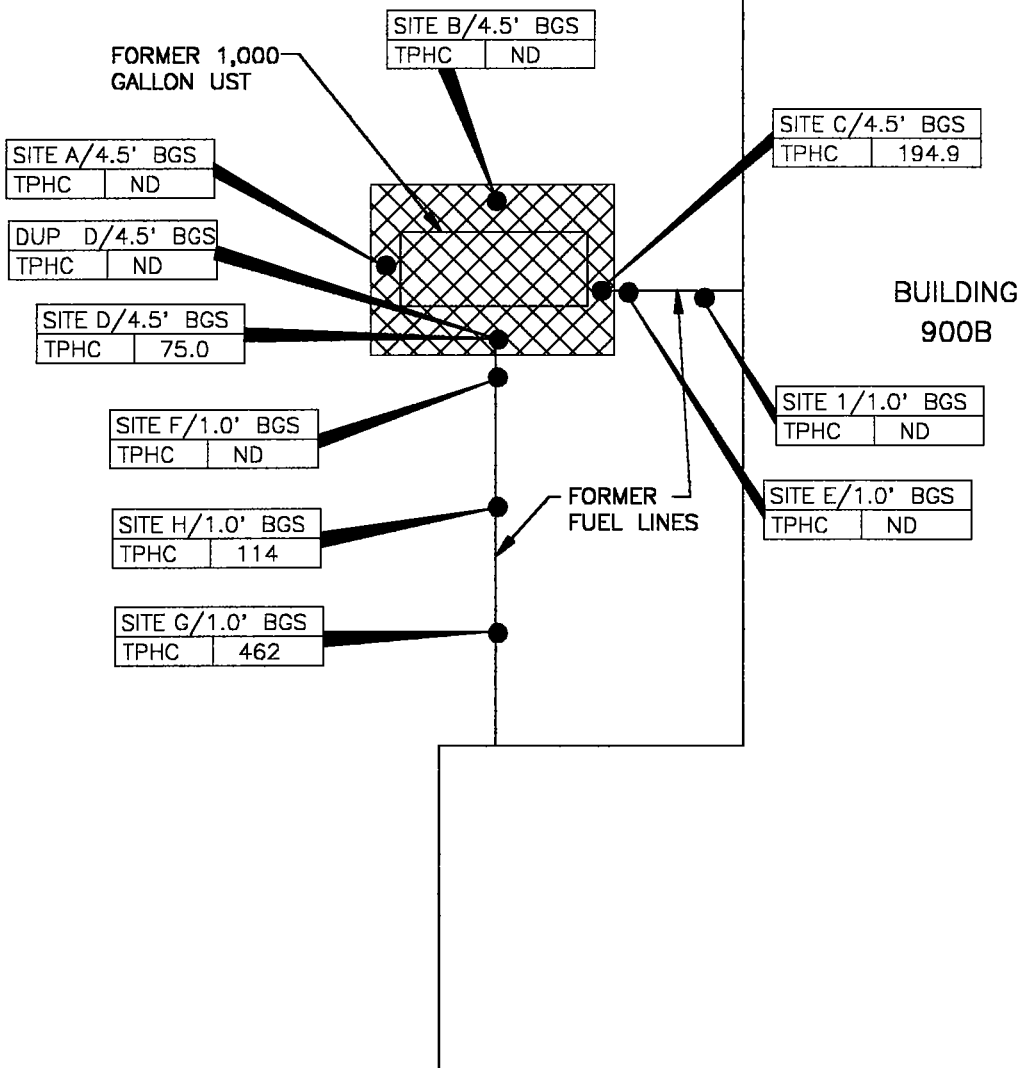
To evaluate soil conditions following removal of the UST and associated piping, post-excavation soil samples were collected on April 3, 1996 from a total of nine (9) locations. All samples were analyzed for TPHC and total solids. The post-excavation sampling results were compared to the NJDEP residential direct contact total organic contaminants soil cleanup criteria of 10,000 mg/kg (N.J.A.C. 7:26D and revisions dated February 3, 1994). A summary of the analytical results and comparison to the NJDEP soil cleanup criteria is provided in Table 2 and the soil sampling locations are shown on Figure 4. The analytical data package is provided in Appendix E.

● SOIL SAMPLE LOCATION (APRIL 3, 1996)

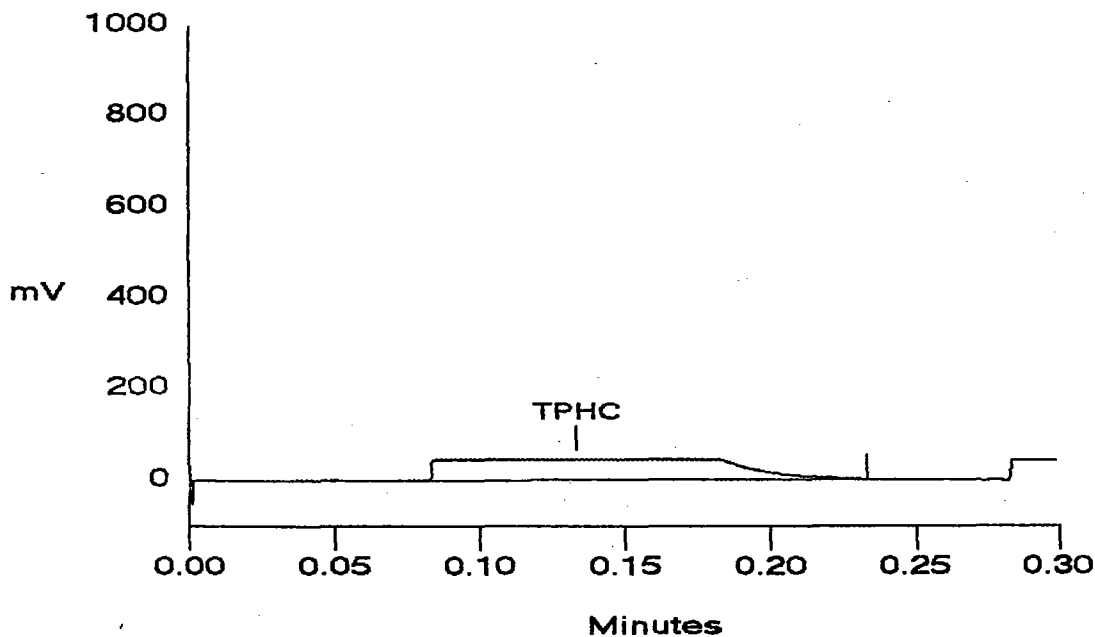
File: 04099631.D02 Sample: CALCK.

Pk. Num	Ret Time	Component Name	Concentration ppm	Height	Area	Bl. Code	%Delta
1	0.13	TPHC	24.668	43851	301422	1	0.00
Totals			24.668	43851	301422

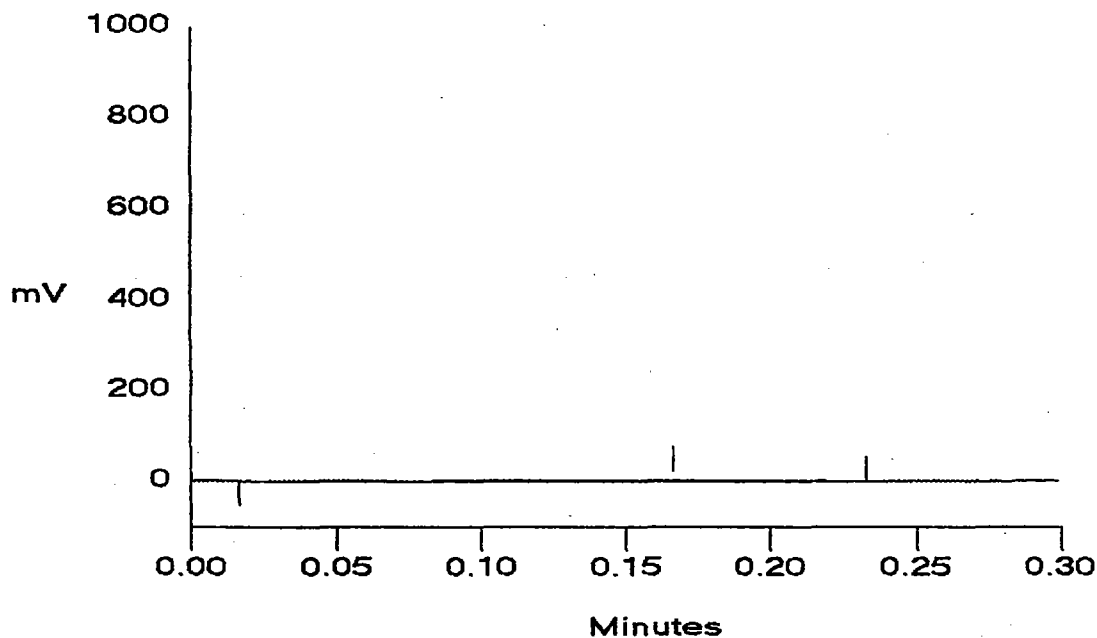
File: 04099631.D03 Sample: 2037.5 900 B-E

Pk. Num	Ret Time	Component Name	Concentration ppm	Height	Area	Bl. Code	%Delta
Totals			0.000	0	0

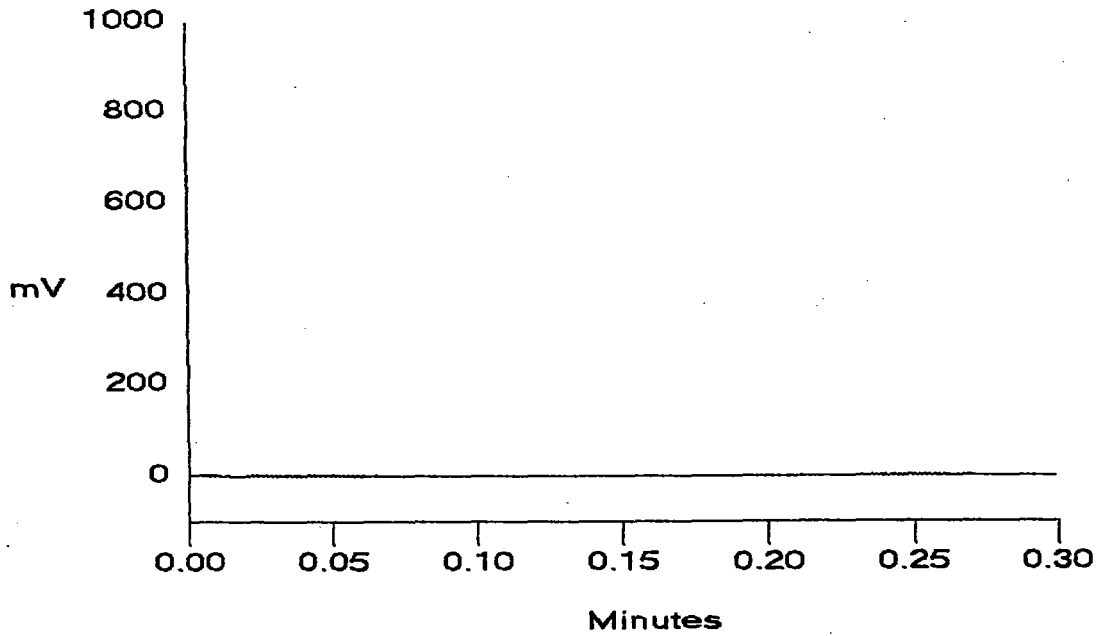
File: 04099631.D04 Sample: 2037.6 900 B-F

Totals			0.000	0	0

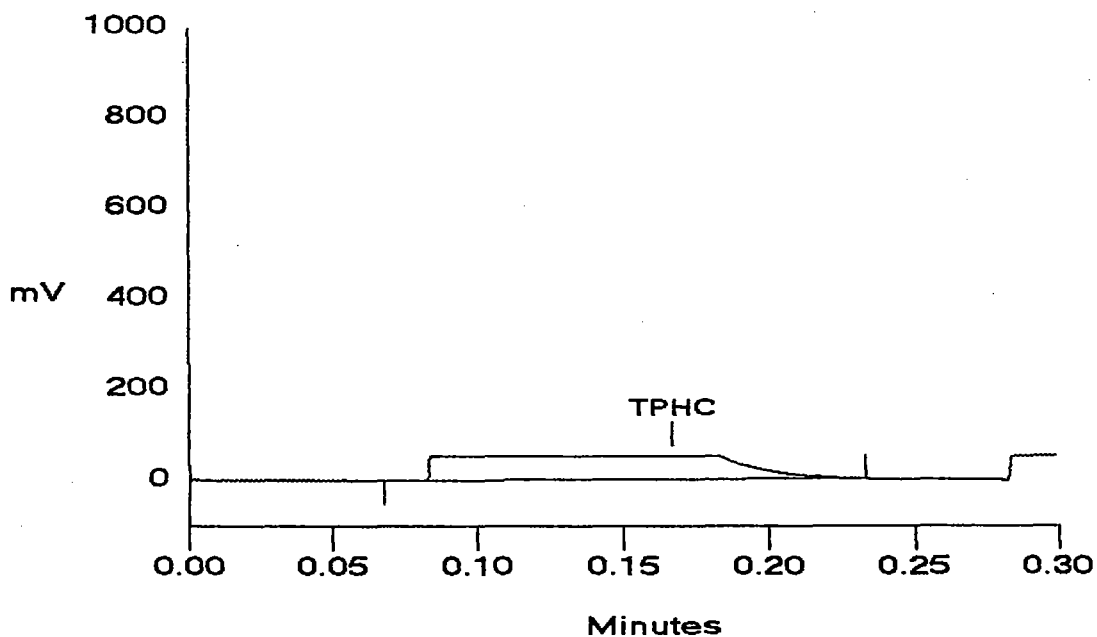
File: 04099631.D05 Sample: 2037.7 900 B-G

Pk. Num	Ret Time	Component Name	Concentration PPM	Height	Area	Bl. Code	%Delta
1	0.17	TPHC	29.398	52259	361474	1	0.00
Totals			29.398	52259	361474

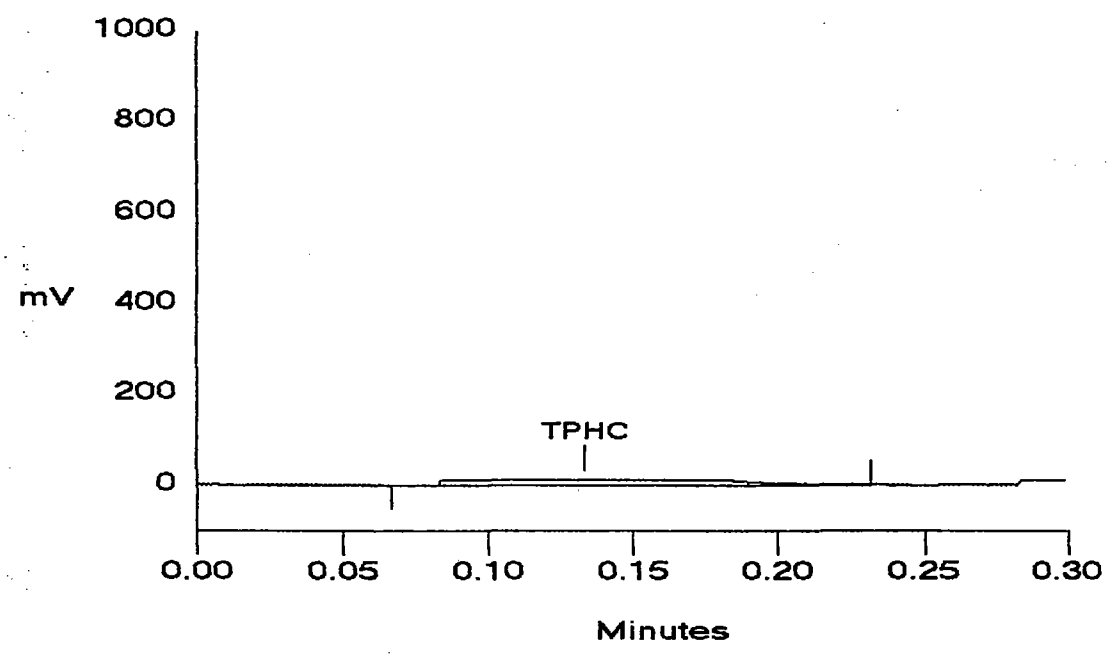
File: 04099631.D06 Sample: 2037.8 900 B-H

Pk. Num	Ret Time	Component Name	Concentration ppm	Height	Area	Bl. Code	%Delta
1	0.13	TPHC	6.206	11033	76944	1	0.00
Totals			6.206	11033	76944

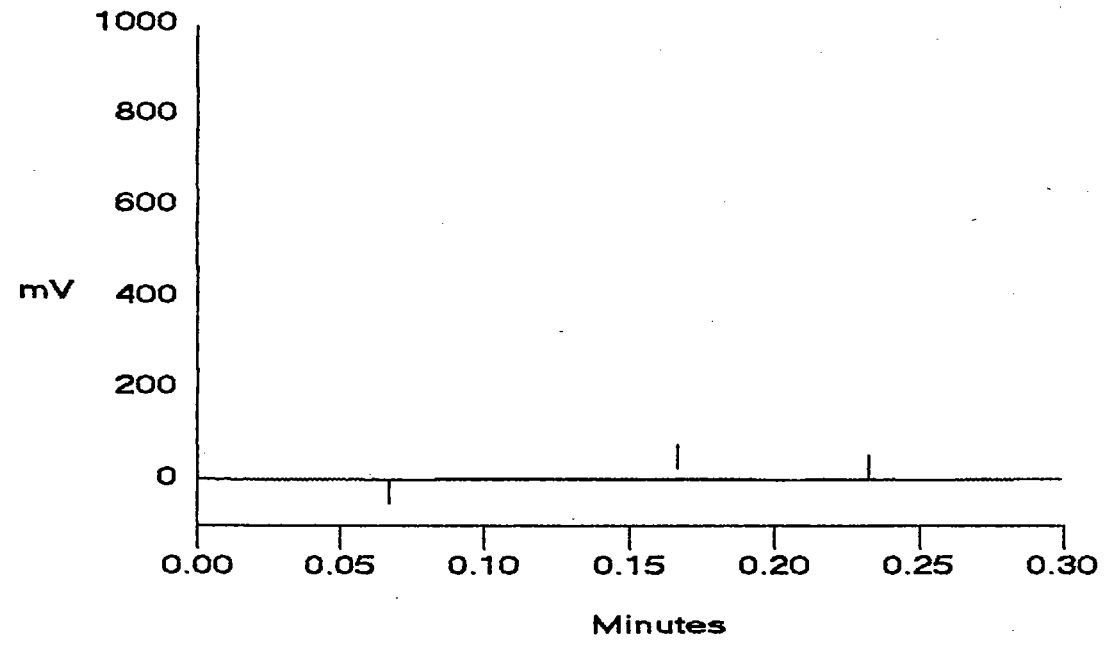
File: 04099631.D07 Sample: 2037.9 900 B-1

Pk. Num	Ret Time	Component Name	Concentration ppm	Height	Area	Bl. Code	%Delta
-----			Totals	0.000	0	0

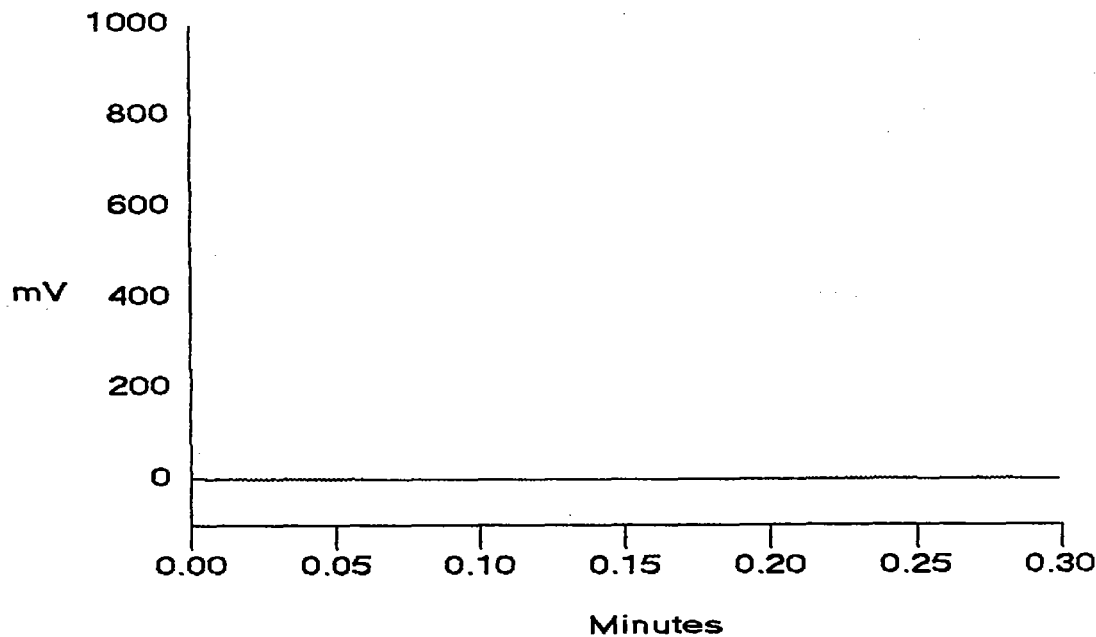
File: 04099631.D08 Sample: 2037.10 900 B-J

Pk. Num	Ret Time	Component Name	Concentration ppm	Height	Area	Bl. Code	%Delta
Totals			0.000	0	0

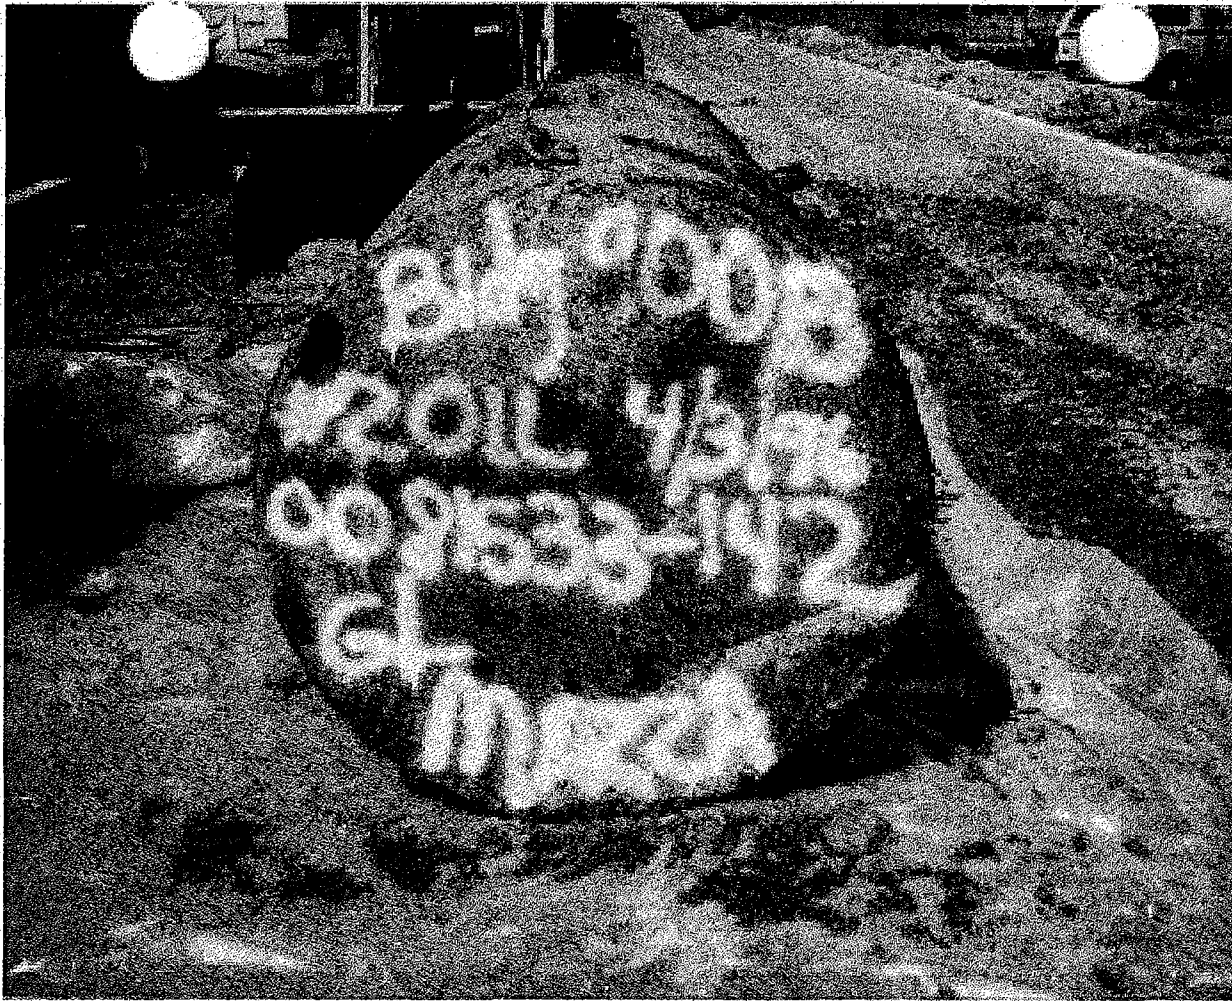
PHOTOGRAPHIC LOG

The tank was transported to Mazza and Sons, Inc., Metal Recyclers. See Appendix D for a copy of the UST disposal certificate and Appendix F for photographs of the UST. The transportation of the UST was in compliance with all applicable regulations and laws.
