**Unregulated Heating Oil Tank Remedial
Investigation and Closure Report**

ECP Parcel 51
Main Post – Bldg. 1123

NJDEP UST Registration No. 1123B & 1123C
NJDEP Spill No.: 09-09-1611-16/09-09-21-1213-31

June 2011

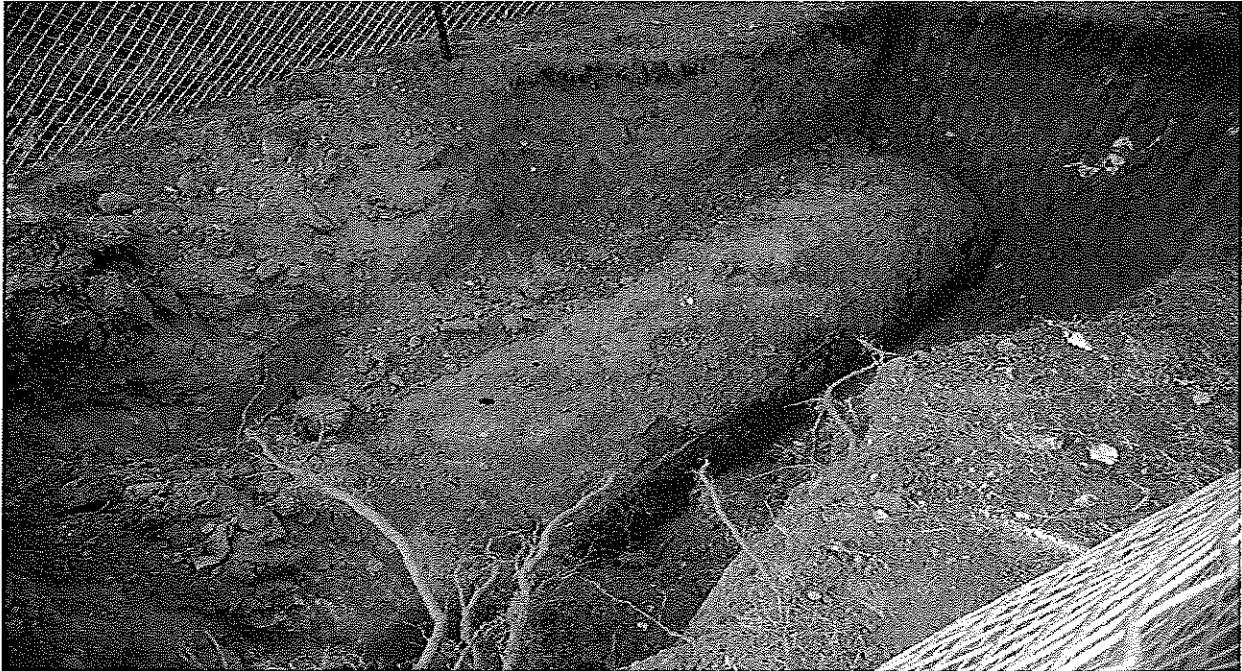
UHOT at Bldg. 1123

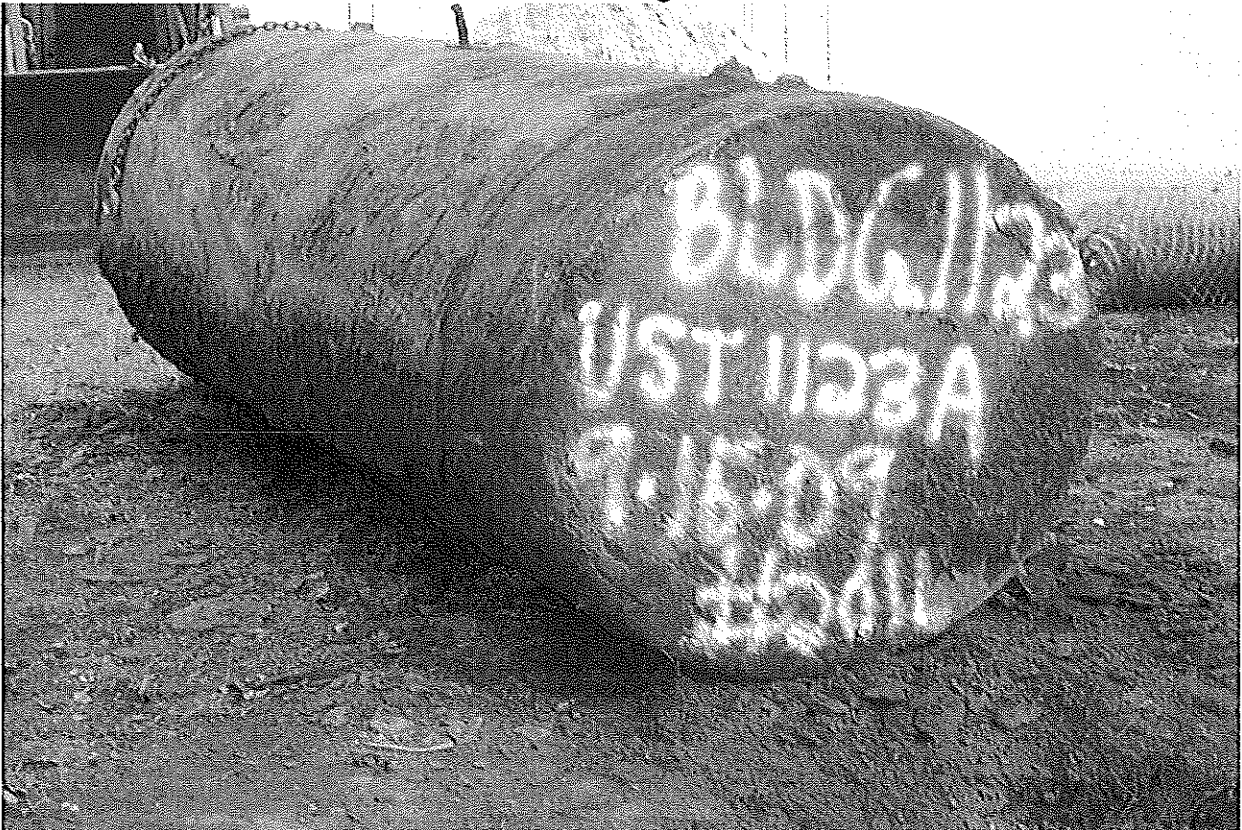
UHOT removed from excavation

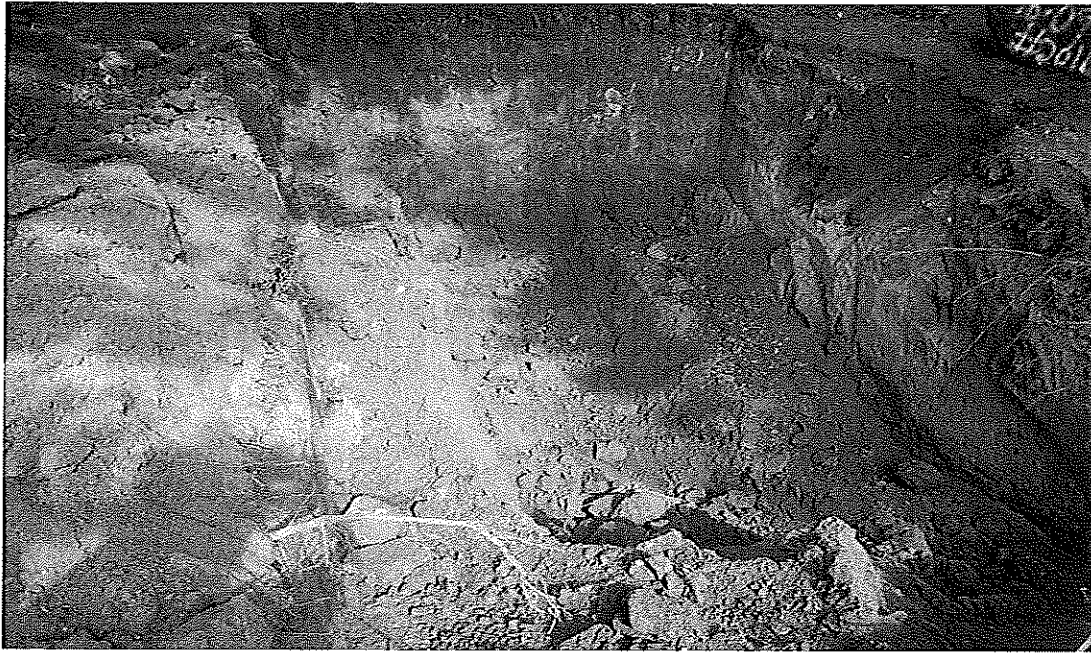
Historical discharge visible

UHOTs 1123B & 1123C were removed in accordance with established protocol, discharges were noted at the following tank removal locations; upon the investigation of the UHOT (1123B), several holes were noted and approximately 12 cubic yards of petroleum impacted soils were removed from the excavation. Following the removal of the second UHOT (1123C) several holes were noted in the exterior and approximately 25 cubic yards of petroleum impacted soils were removed to the soil staging area at Bldg. 108.

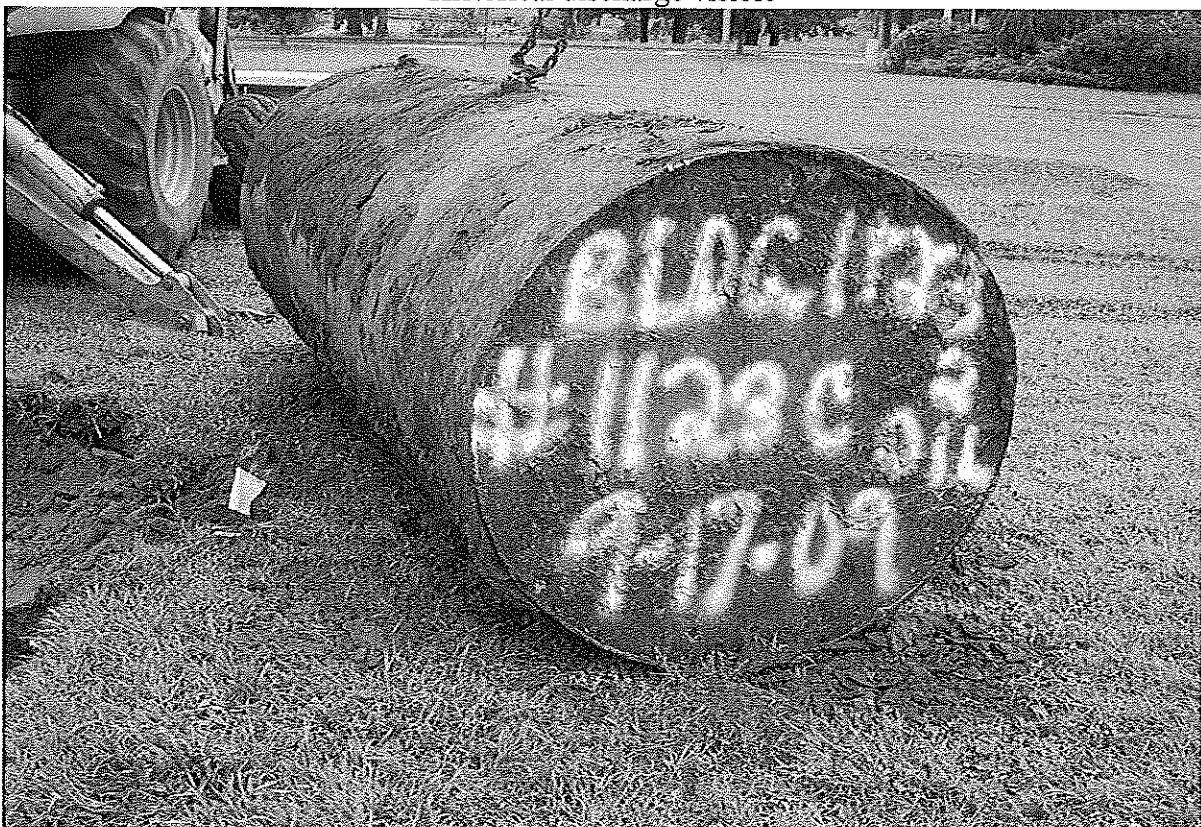
Second UHOT removed from Bldg. 1123

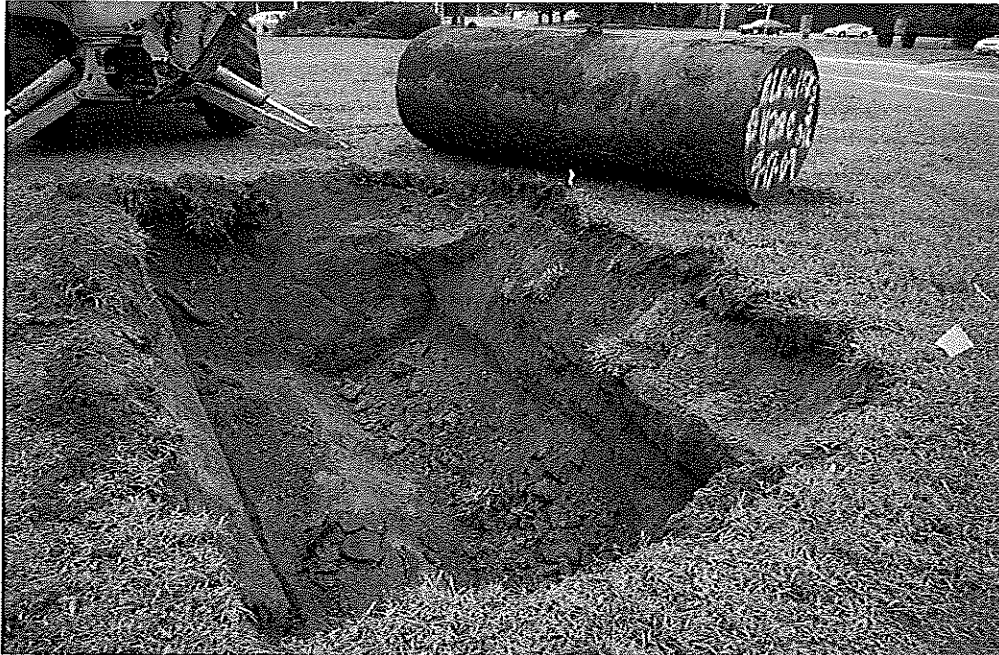
Excavation of second UHOT, note staining in bottom left of photo

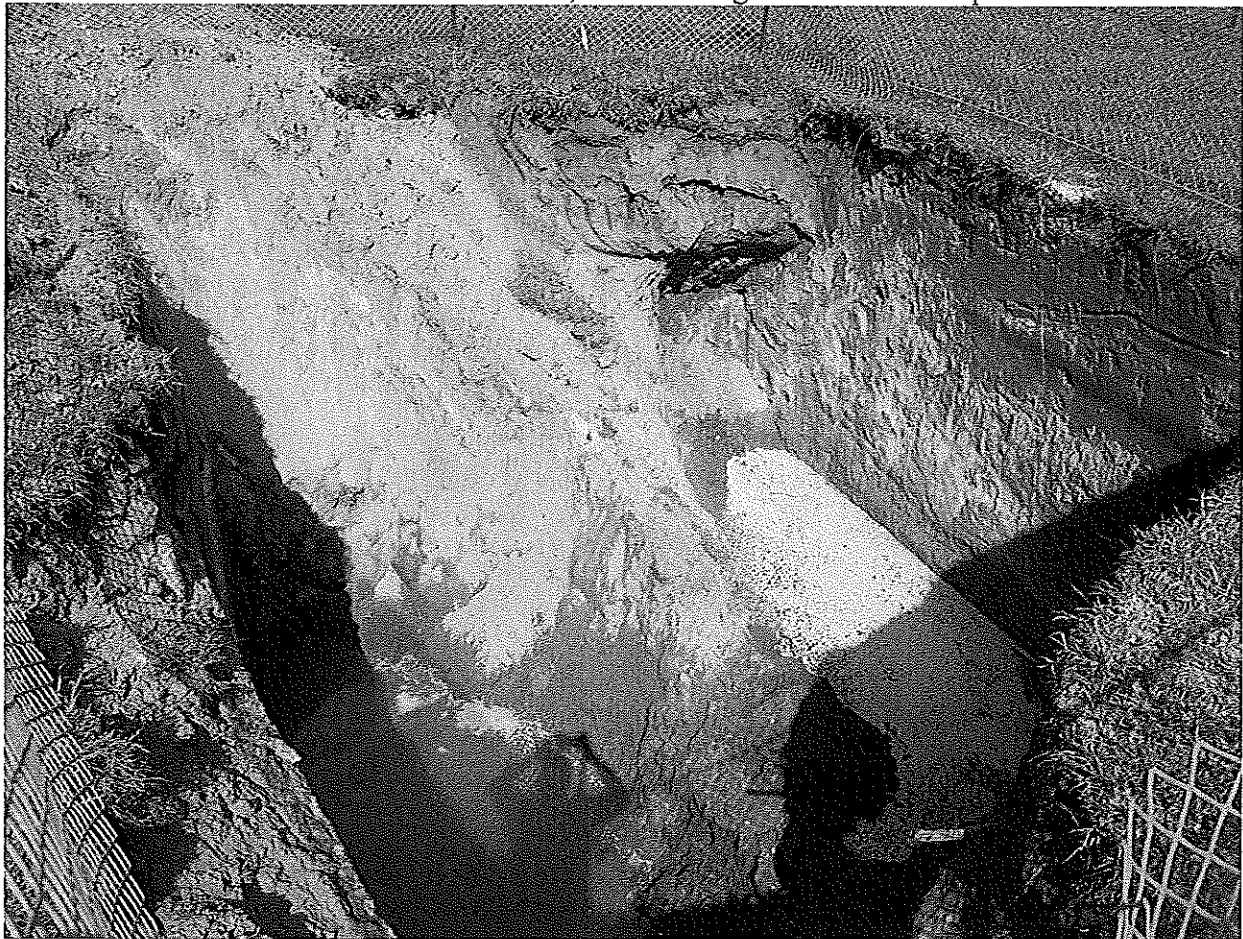
Completed remediation at I123

Following receipt of all post-excavation soil sampling Total Petroleum Hydrocarbon (TPH) results, the excavations were backfilled to grade with a combination of uncontaminated excavated soil and crushed stone. The excavation sites were then restored to its original condition with four inches of asphalt and/or top soil and grass seed.
