**Underground Storage Tank Closure  
and Site Investigation Report**

*Charles Wood – Building 2022*

**NJDEP UST Registration No.: 192486-3**  
**UST No.: 192486-3**

**September 2010**

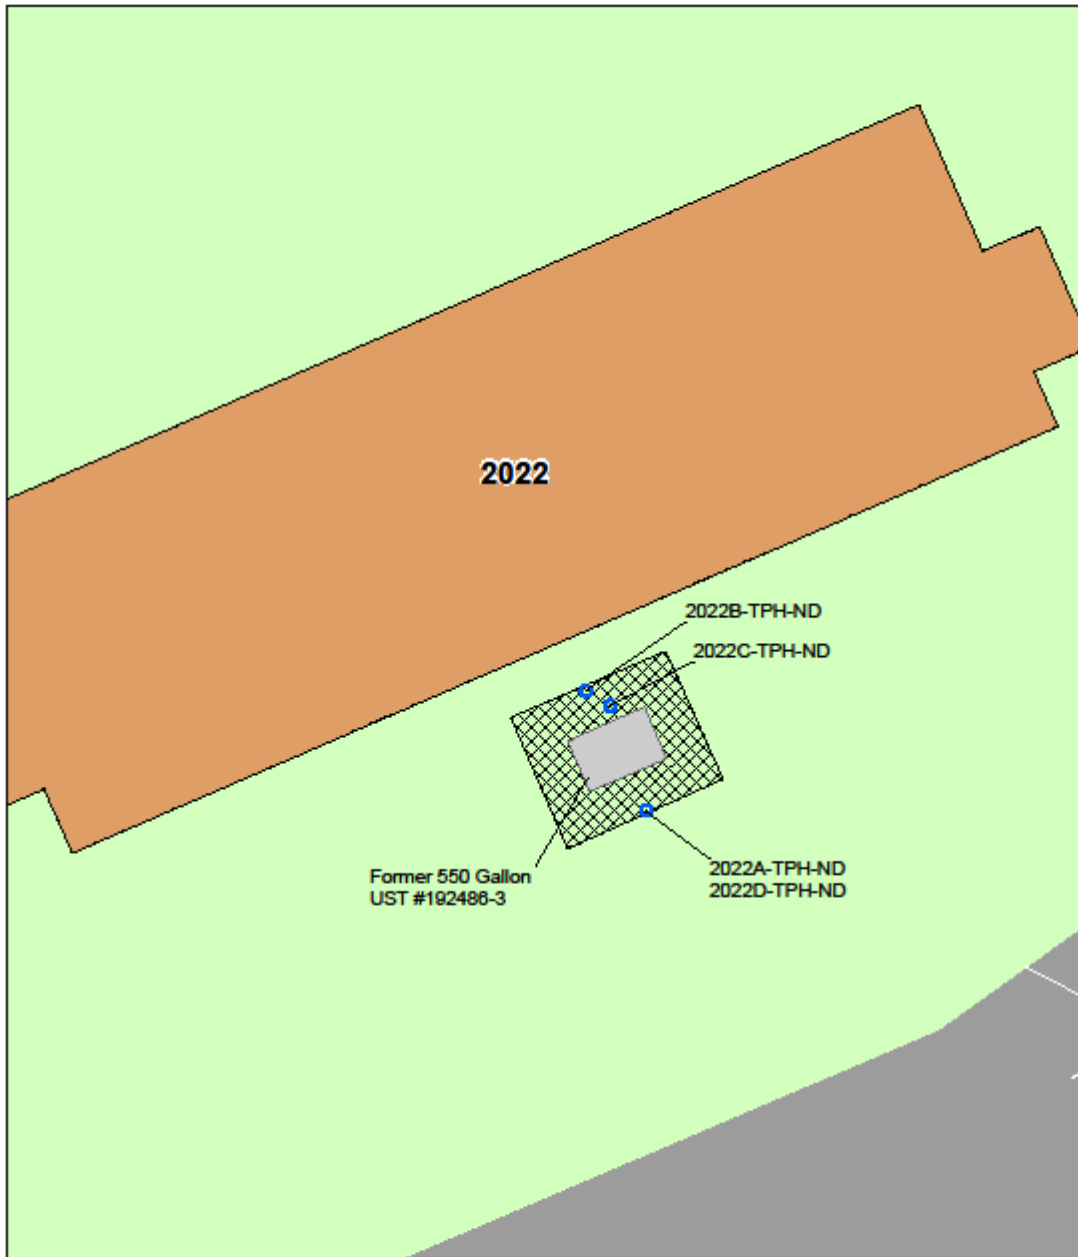
**Figure 3**

Refer to soil sampling location map in Figure 3. All samples were analyzed for total petroleum hydrocarbons (TPH). Groundwater was not encountered in the excavation.

Soil Sampling Location Map  
 Building 2022, Charles Wood Area  
 Fort Monmouth, NJ  
 Date: 1/2011  
 UST Registration # 192486-3  
 UST Discharge # NA
