**Underground Storage Tank Closure
and Site Investigation Report**

Charles Wood – Building 2023

NJDEP UST Registration No.: 192486-4
UST No.: 192486-4

September 2010

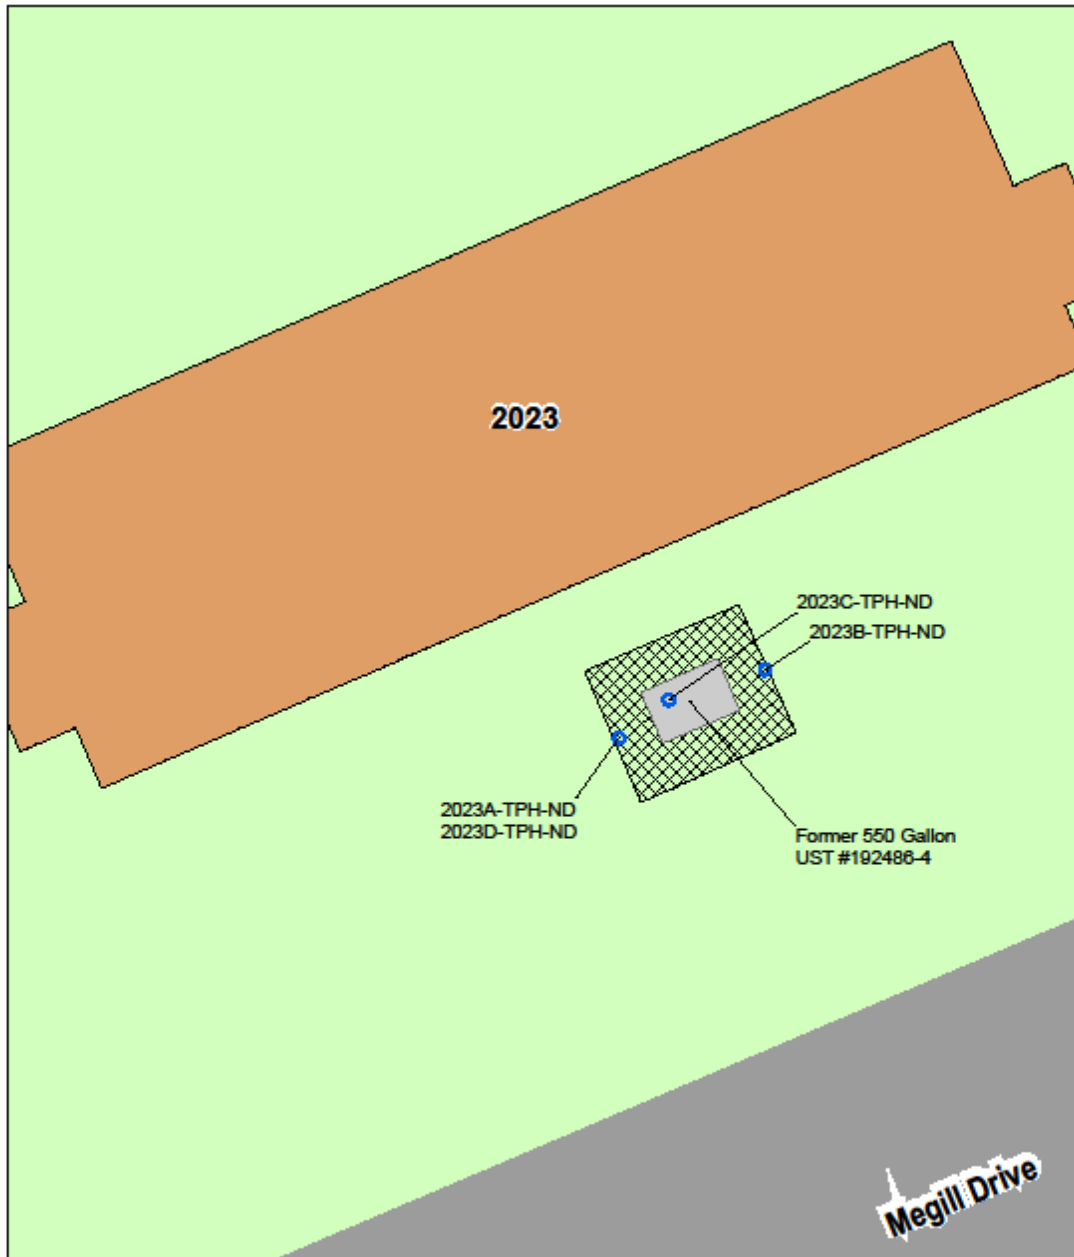
Figure 3

Refer to soil sampling location map in Figure 3. All samples were analyzed for total petroleum hydrocarbons (TPH). Groundwater was not encountered in the excavation.

Soil Sampling Location Map
 Building 2023, Charles Wood Area
 Fort Monmouth, NJ
 Date: 1/2011
 UST Registration # 192486-4
 UST Discharge # NA
