**Underground Storage Tank Closure
and Site Investigation Report**

Charles Wood – Building 2024

NJDEP UST Registration No.: 192486-5
UST No.: 192486-5

September 2010

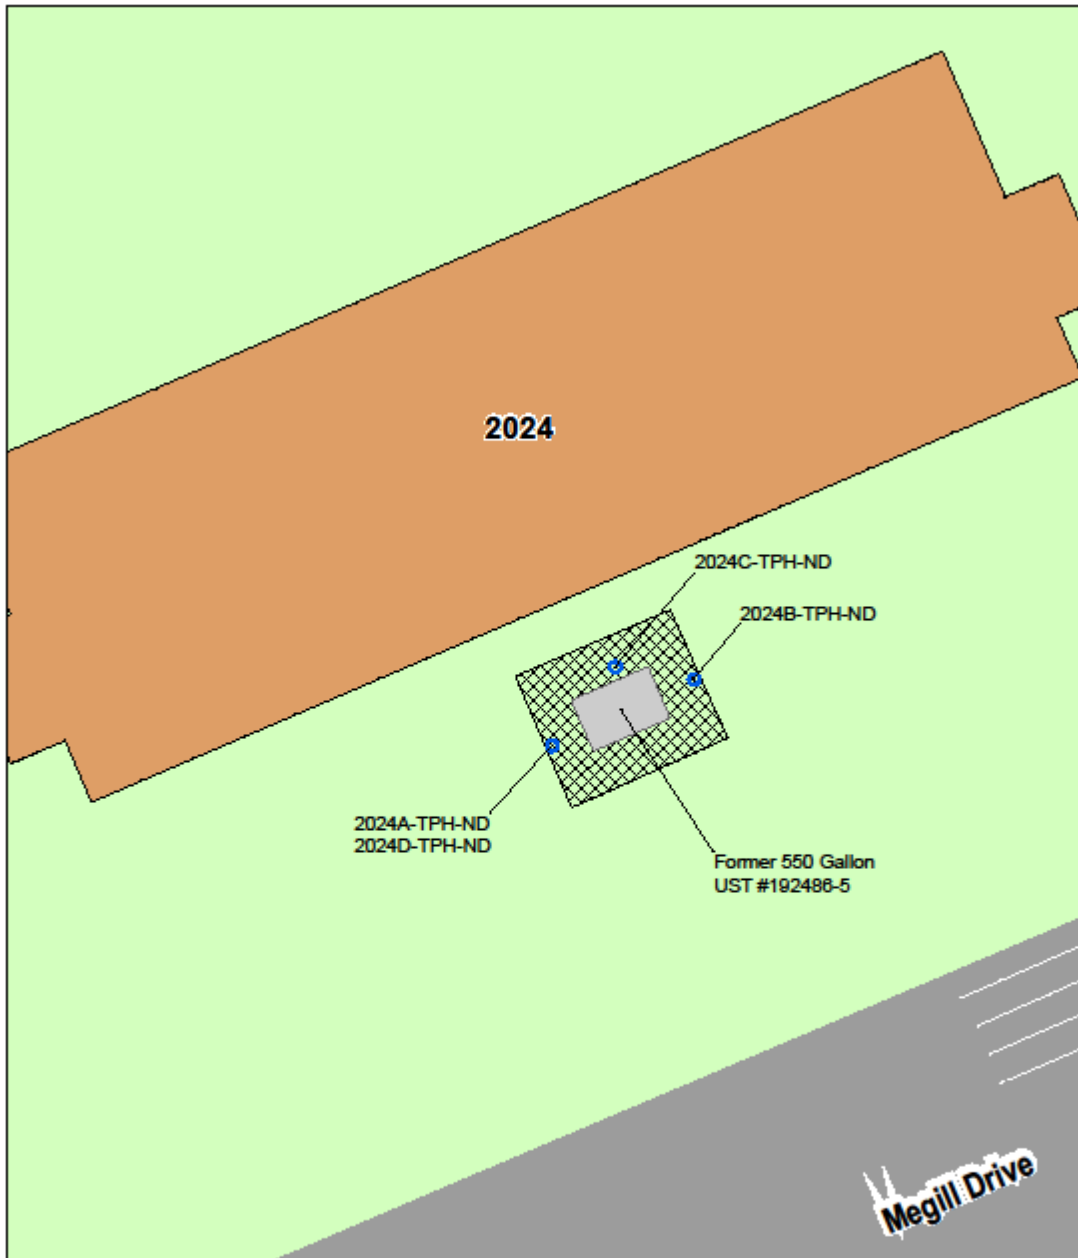
Figure 3
 Soil Sampling Location Map
 Building 2024, Charles Wood Area
 Fort Monmouth, NJ
 Date: 1/2011
 UST Registration # 192486-5
 UST Discharge # NA

Building 2024 (Megill Drive) is located in the Charles Wood area of Fort Monmouth, as shown on Figure 1 & 2. UST No.: 192486-5 and associated piping were located adjacent to the building, as shown on Figure 3.

On January 19, 2000, closure soil samples were collected after the removal of the UST. Closure samples 2024-A and 2024-B were collected from a total of two (2) locations along the UST bottom of the excavation for the UST No.: 192486-5. Closure sample 2024-C was collected from a location along the UST piping. A duplicate of sample 2024-A was collected.

Refer to soil sampling location map in Figure 3. All samples were analyzed for total petroleum hydrocarbons (TPH). Groundwater was not encountered in the excavation.
