**Underground Storage Tank Closure  
and Site Investigation Report**

*Charles Wood – Building 2029*

**NJDEP UST Registration No.: 192486-10**  
**UST No.: 192486-10**

**September 2010**

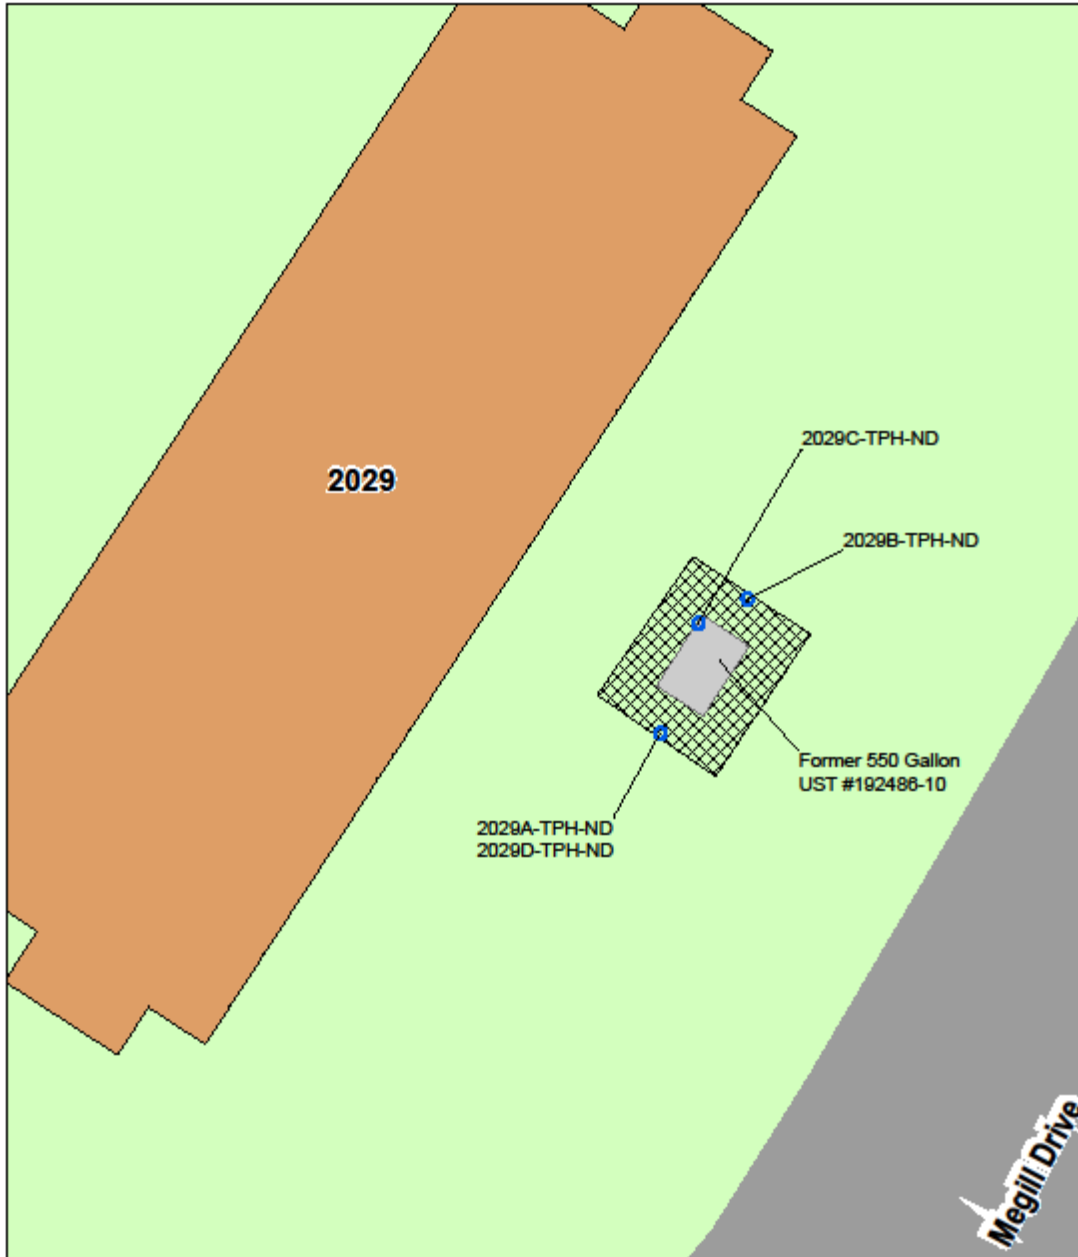
**Figure 3**  
 Soil Sampling Location Map  
 Building 2029, Charles Wood Area  
 Fort Monmouth, NJ  
 Date: 1/2011  
 UST Registration # 192486-10  
 UST Discharge # NA

Building 2029 (Megill Drive) is located in the Charles Wood area of Fort Monmouth, as shown on Figure 1 & 2. UST No.: 192486-10 and associated piping were located adjacent to the building, as shown on Figure 3.

On February 22, 2000, closure soil samples were collected after the removal of the UST. Closure samples 2029-A and 2029-B were collected from a total of two (2) locations along the UST bottom of the excavation for the UST No.: 192486-10. Closure sample 2029-C was collected from a location along the UST piping. A duplicate of sample 2029-B was also collected. Refer to soil sampling location map in Figure 3.
