**Underground Storage Tank Closure
and Site Investigation Report**

Charles Wood – Building 2032

NJDEP UST Registration No.: 192486-13
UST No.: 192486-13

September 2010

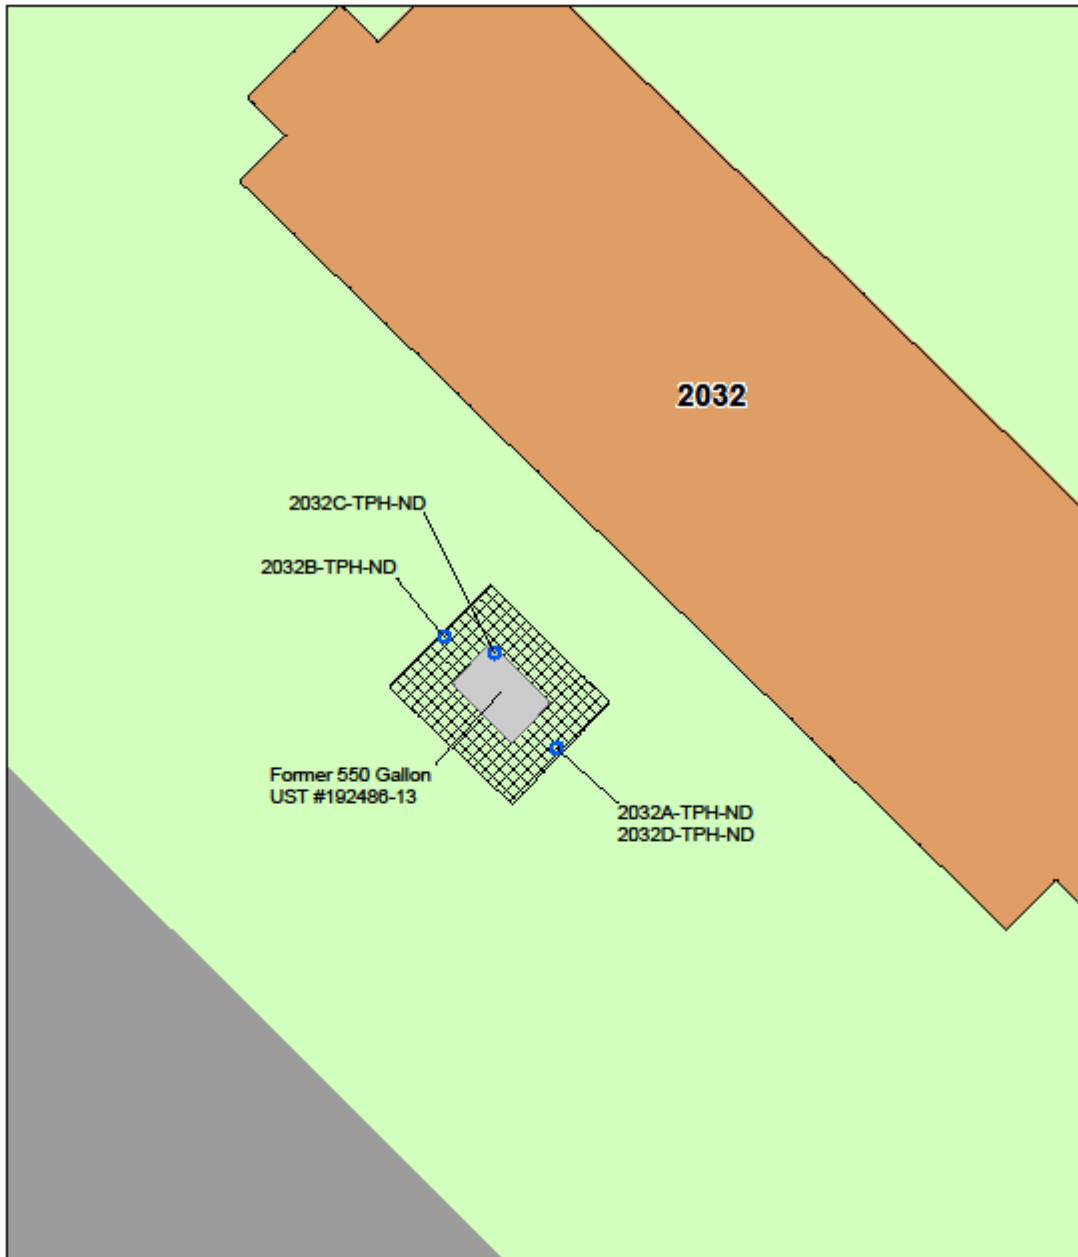
Figure 3
 Soil Sampling Location Map
 Building 2032, Charles Wood Area
 Fort Monmouth, NJ
 Date: 1/2011
 UST Registration # 192486-13
 UST Discharge # NA

- Legend**
- ▭ UST
 - ▣ UST Excavation Limits
 - Soil Sample - 3/2/2000

Building 2032 (Megill Circle) is located in the Charles Wood area of Fort Monmouth, as shown on Figure 1 & 2. UST No.: 192486-13 and associated piping were located adjacent to the building, as shown on Figure 3.

On March 2, 2000, closure soil samples were collected after the removal of the UST. Closure samples 2032-A and 2032-B were collected from a total of two (2) locations along the UST bottom of the excavation for the UST No.: 192486-13. Closure sample 2032-C was collected from a location along the UST piping. A duplicate of sample 2032-A was also collected.

Refer to soil sampling location map in Figure 3. All samples were analyzed for total petroleum hydrocarbons (TPH). Groundwater was not encountered in the excavation.
