**Underground Storage Tank Closure
and Site Investigation Report**

Charles Wood – Building 2037

NJDEP UST Registration No.: 192486-18
UST No.: 192486-18

September 2010

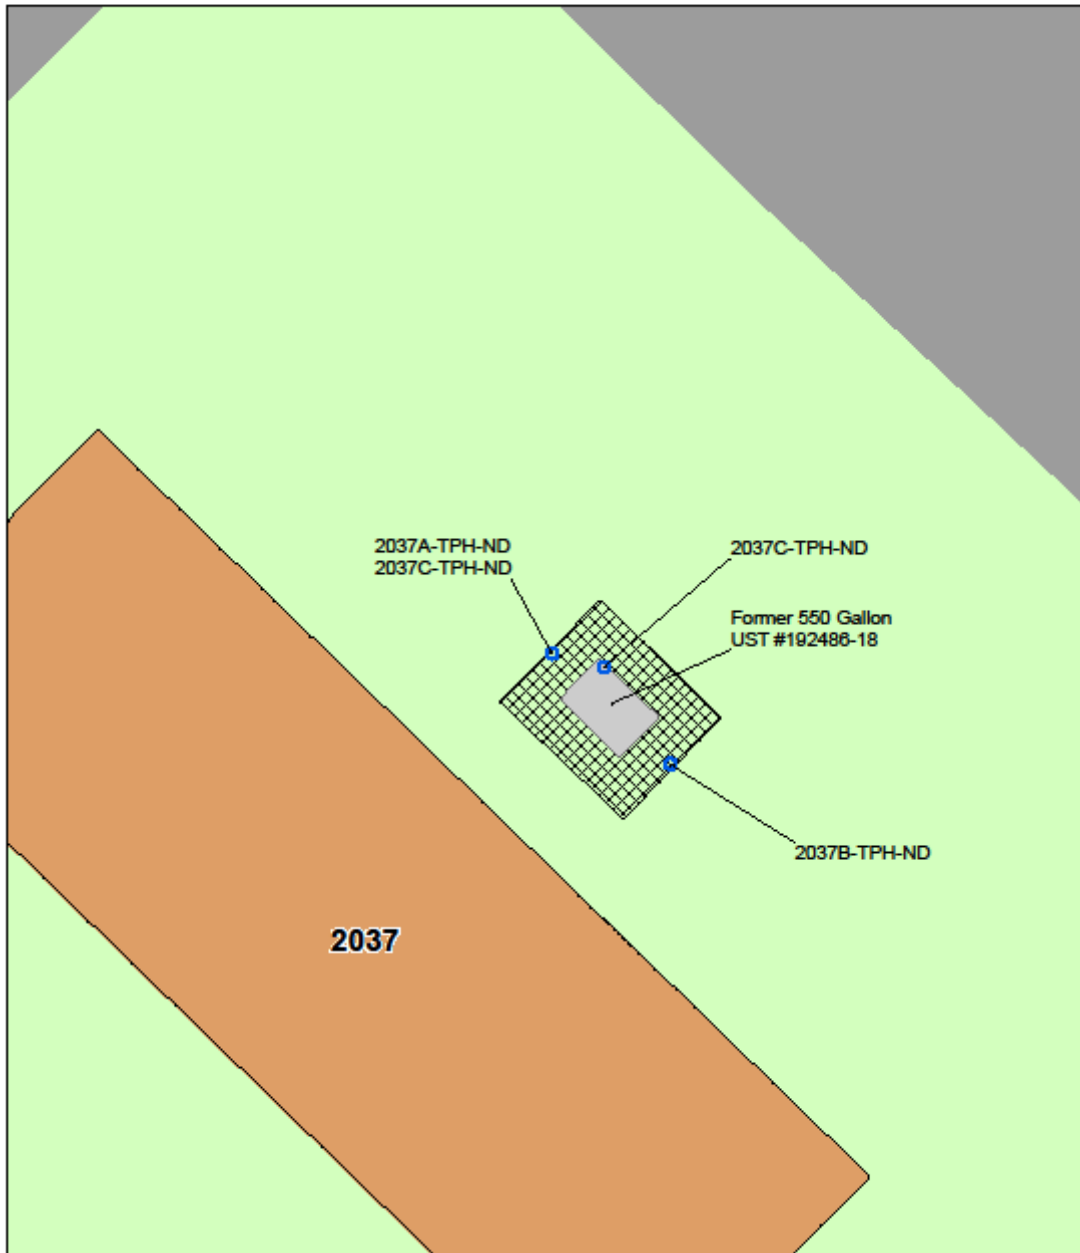
Figure 3
 Soil Sampling Location Map
 Building 2037, Charles Wood Area
 Fort Monmouth, NJ
 Date: 1/2011
 UST Registration # 192486-18
 UST Discharge # NA

On March 23, 2000, closure soil samples were collected after the removal of the UST. Closure samples 2037-A and 2037-B were collected from a total of two (2) locations along the UST bottom of the excavation for the UST No.: 192486-18. Closure sample 2037-C was collected from a location along the UST piping. A duplicate of sample 2037-A was also collected.

Refer to soil sampling location map in Figure 3. All samples were analyzed for total petroleum hydrocarbons (TPH). Groundwater was not encountered in the excavation.

- Legend**
- UST
 - UST Excavation Limits
 - C Soil Sample - 3/23/2000
