**Underground Storage Tank
Closure and Site Investigation
Report**

***Building 2533
Charles Wood Area***

COPY
NJDEP UST Registration No. 0081515-23

December 1997

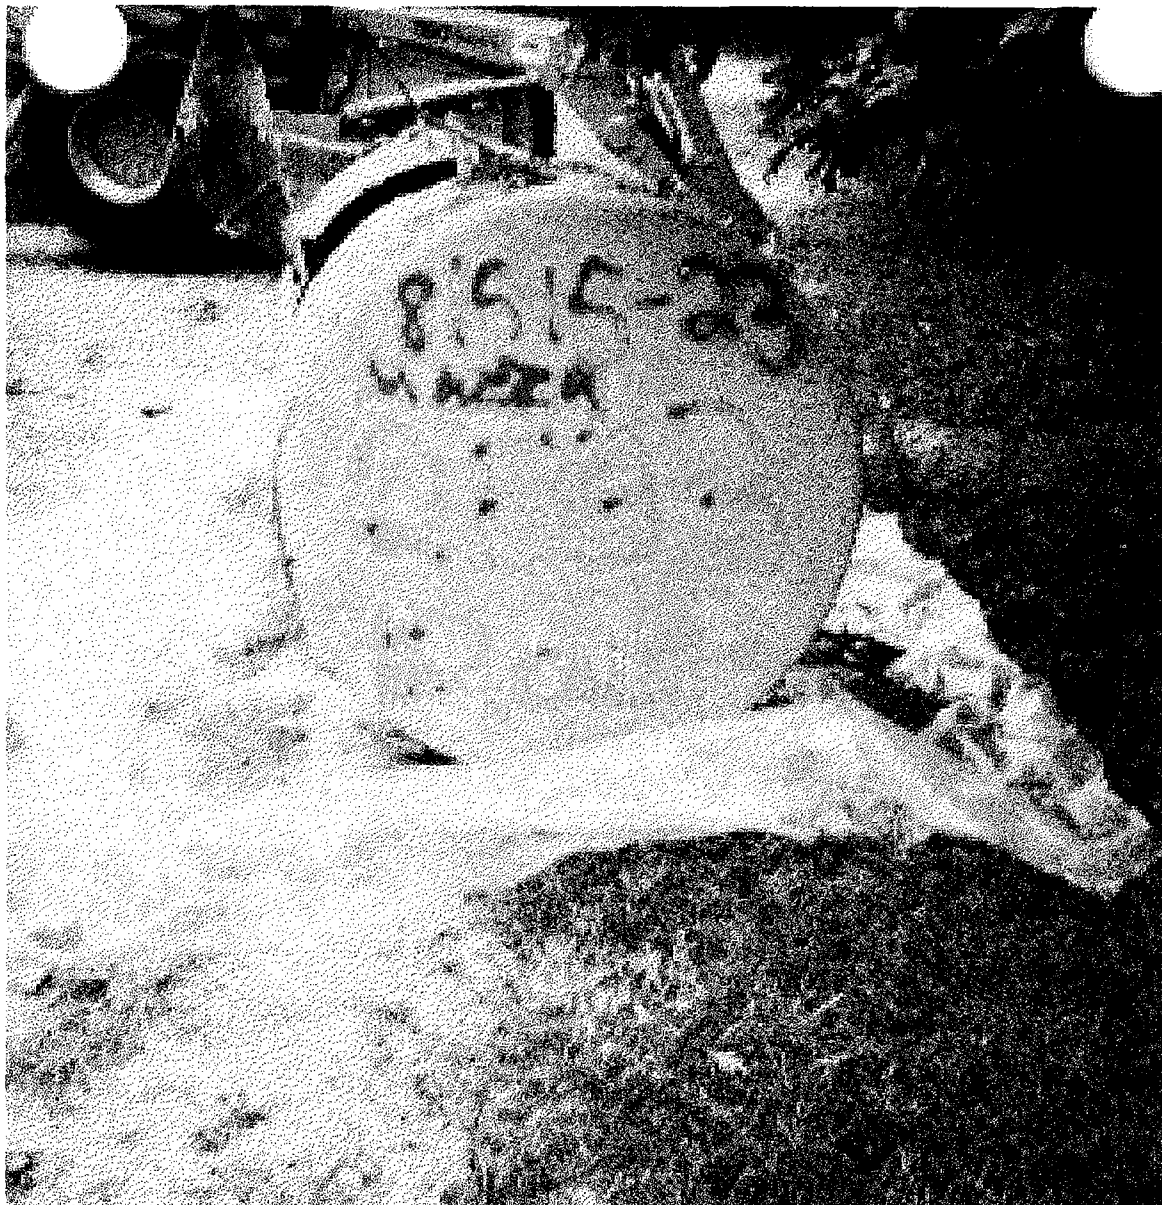
PHOTOGRAPHIC LOG

The fiberglass-coated steel tank was transported to the Mazza & Sons, Inc. for disposal in compliance with all applicable regulations and laws. See Appendix F for photographs of the tank.
